THE DEVELOPMENT OF TIMBER FRAMING IN SURREY'S OLD BUILDINGS

An analysis and calibration by means of tree-ring dating

Rod Wild and Andy Moir

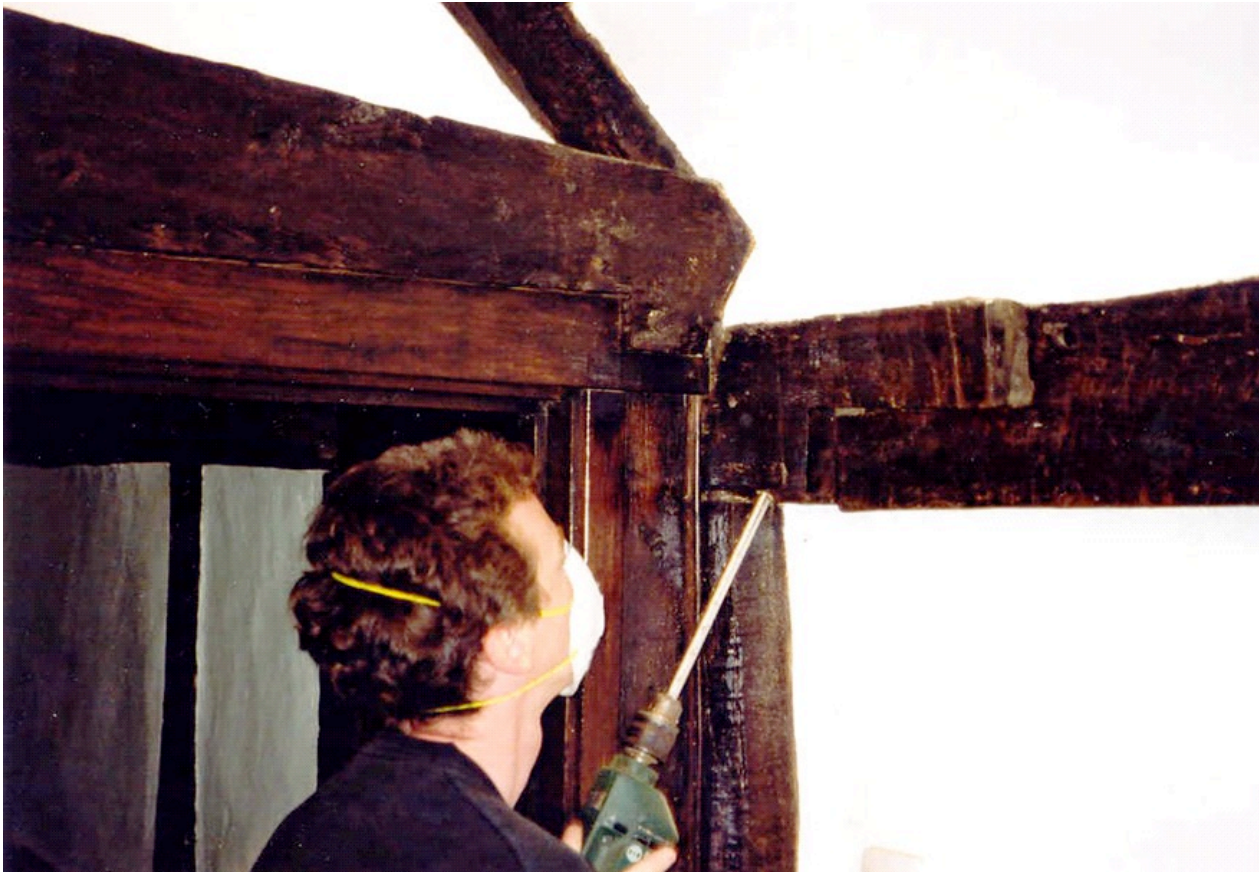
Fig 1 Taking a dendrochronology sample.

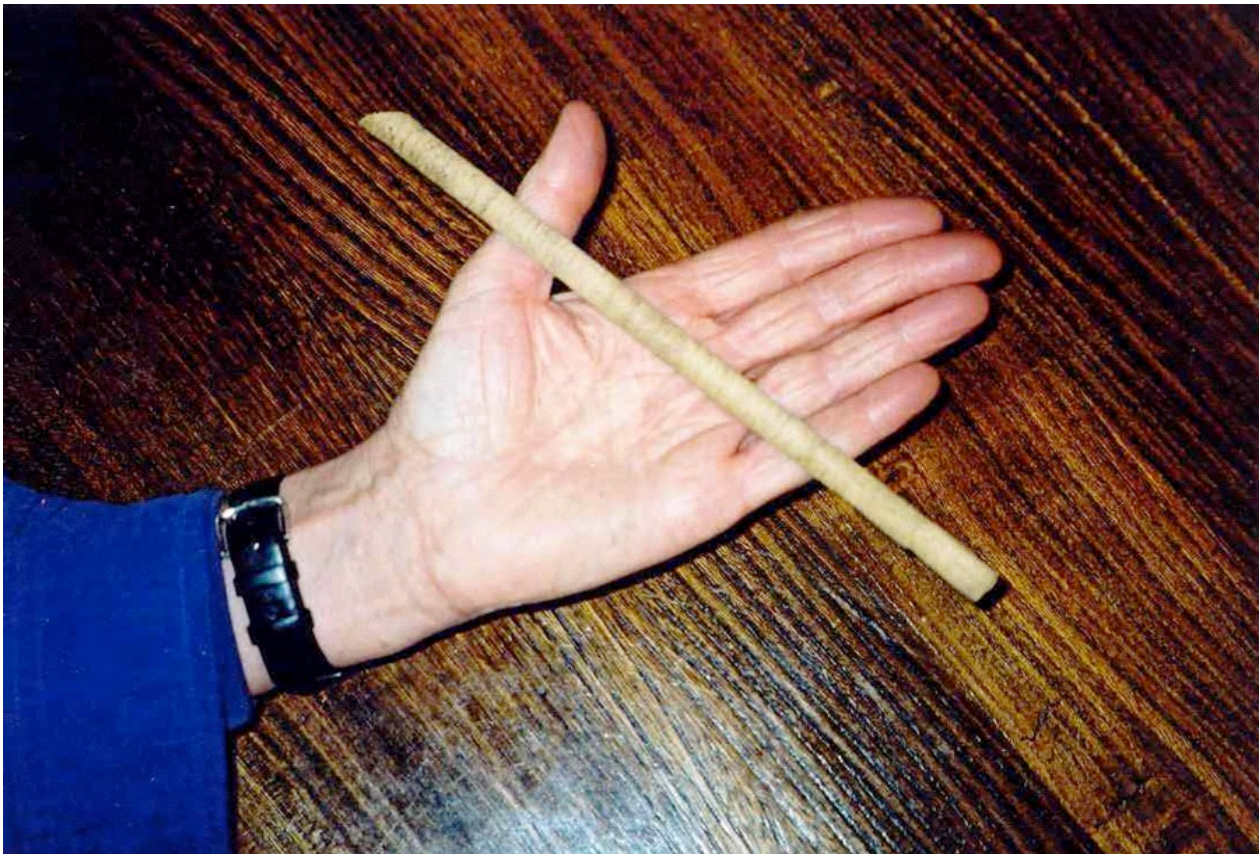
Fig 2 A dendrochronology core.

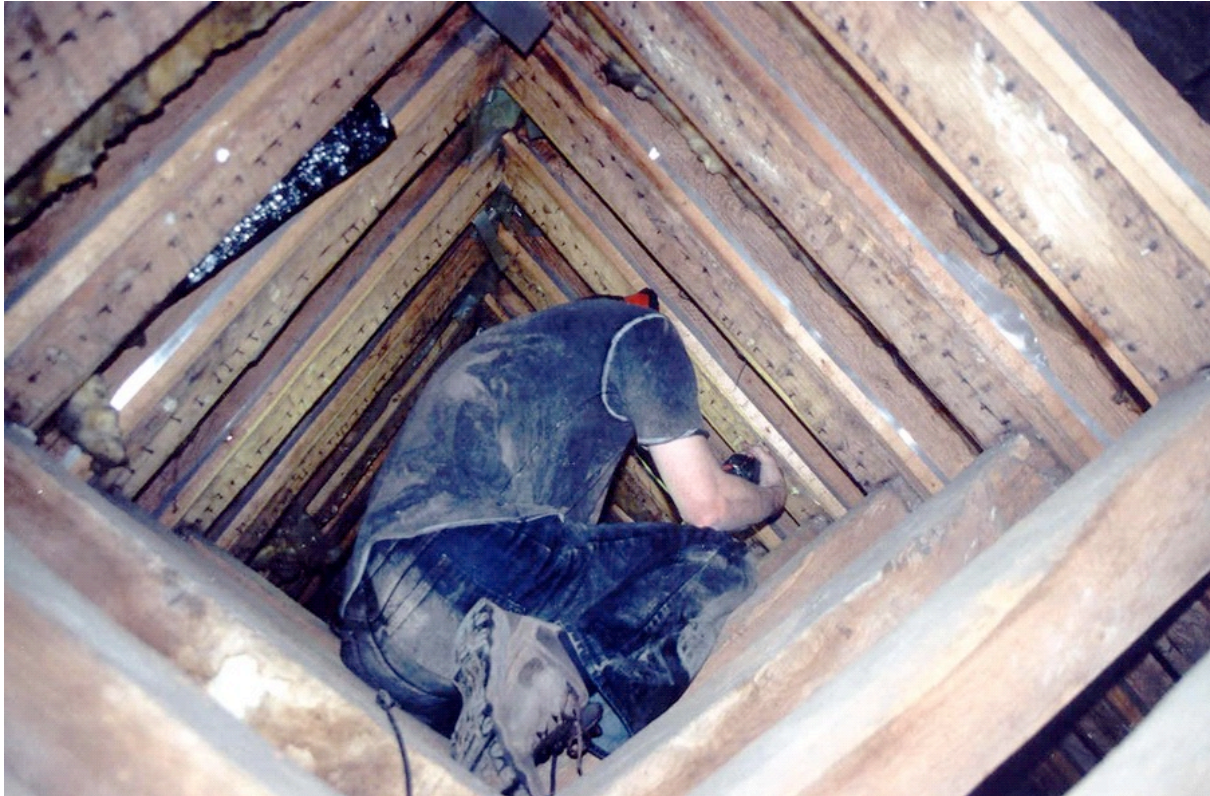
Fig 4 **Bishop's Camera, Farnham Castle** (dated 1381). Andy Moir working above the scissor bracing in the roof of the. Sometimes agility is needed as well as dendrochronology.

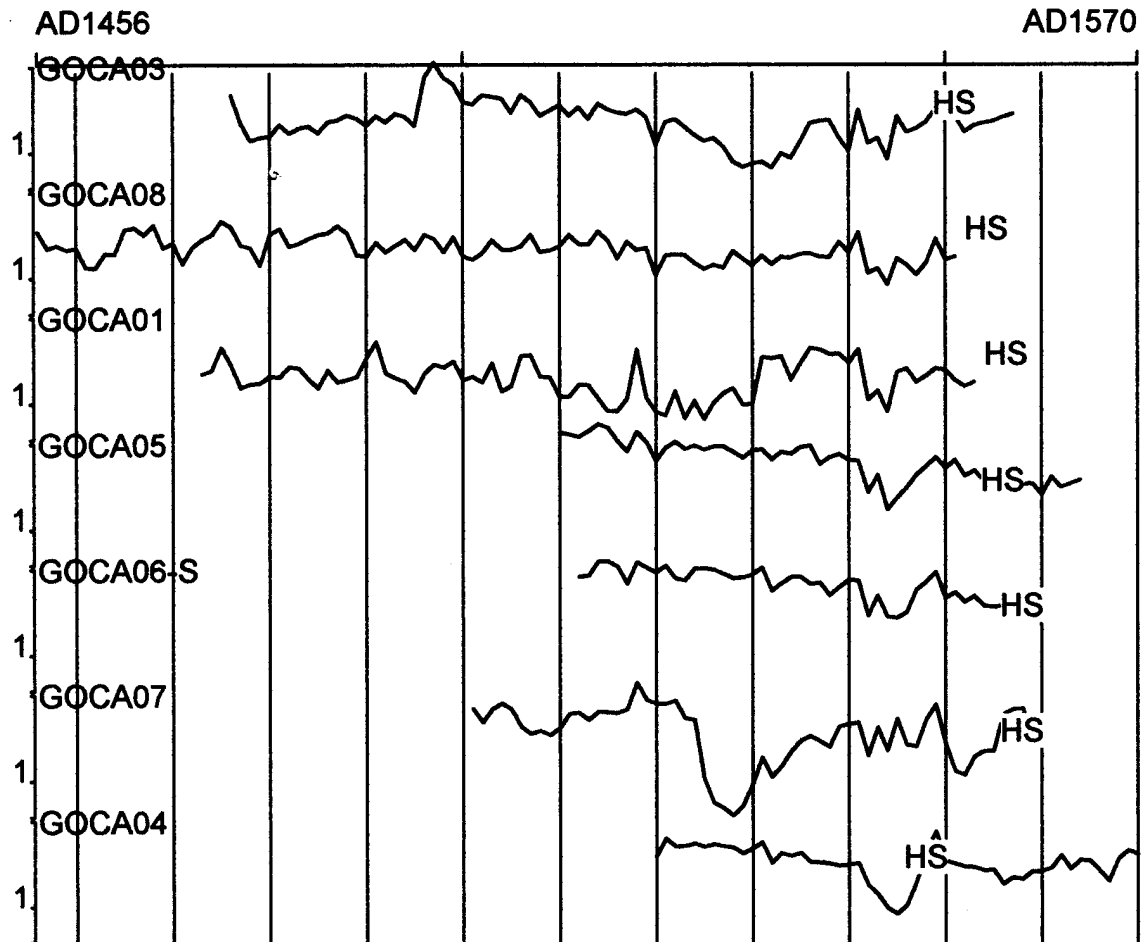
NOTE: The ring width (mm) is plotted on a (y axis) logarithmic scale, using a common axis for all sequences.
H/S = heartwood/sapwood boundary

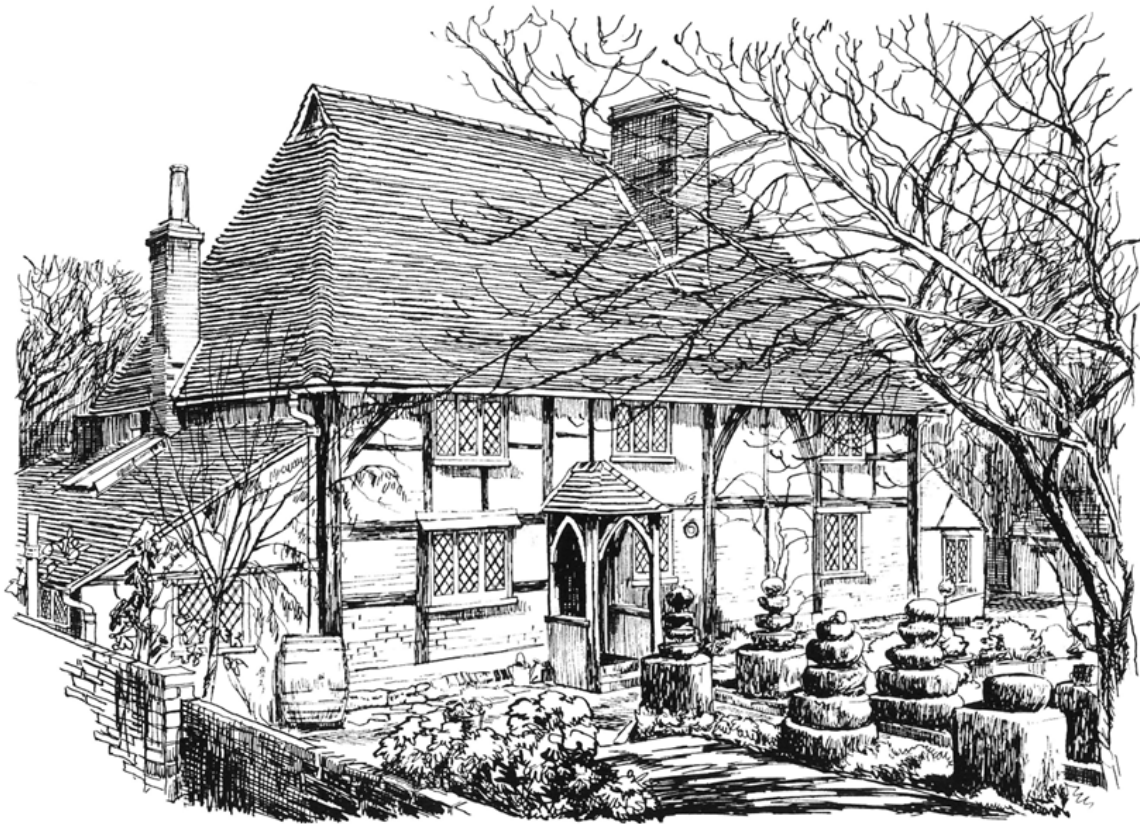
Fig 8 **The Old Cottage, West Horsley**, is a medieval open-hall house with a tall crown-post roof and arch braces in the framing. A combination of dendrochronology and archaeology was needed to understand the building and establish that, while it was built in 1445, the western (left-hand) bay was rebuilt in 1563. Drawing by John L Baker, reproduced courtesy of the *Surrey Advertiser*.

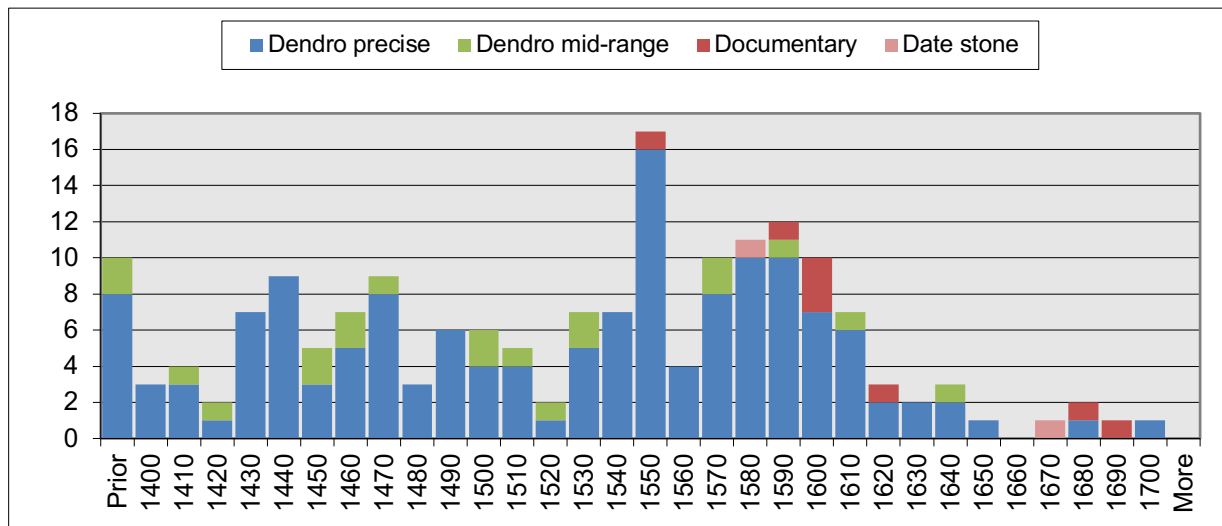
Fig 10 **The distribution of dates and method of dating** for 228 buildings or building additions with valid and useful data. (The time period is in single decades, so for example, 1540 means the 1540s or 1540–49). Note that datings by means of date stones or documentary sources were used only if they were thought to be secure - many are not.

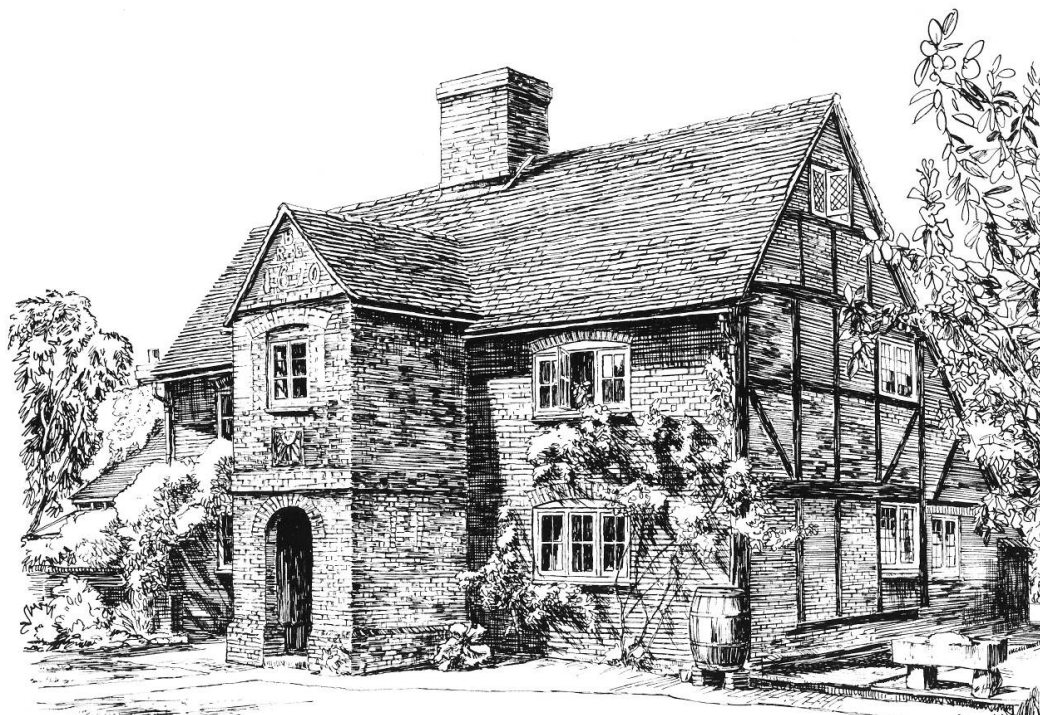
Fig 11 **Whites Farm, Worplesdon**, is a central-chimney house with some timber framing remaining to the side. There is a fine two-storey porch of a kind sometimes seen in Surrey (see also Frosbury Farmhouse, frontispiece). The date of 1670sto (see below) can be seen on the front of the porch, picked out in flints. There is evidence in the roof that the porch is coeval with the main house, so the date applies equally to both. Not visible from the front is an older part to the rear, probably 16th century. Drawing by John L Baker, reproduced courtesy of the *Surrey Advertiser*.

example, Lockhurst Hatch, Albury, 1607doc. A few more are derived from date stones or a firm inscription of some type. Again, these are only used in this survey if they seem secure and are backed up by expert stylistic dating. An example would be Whites Farm, Worplesdon, 1670sto (fig 11).

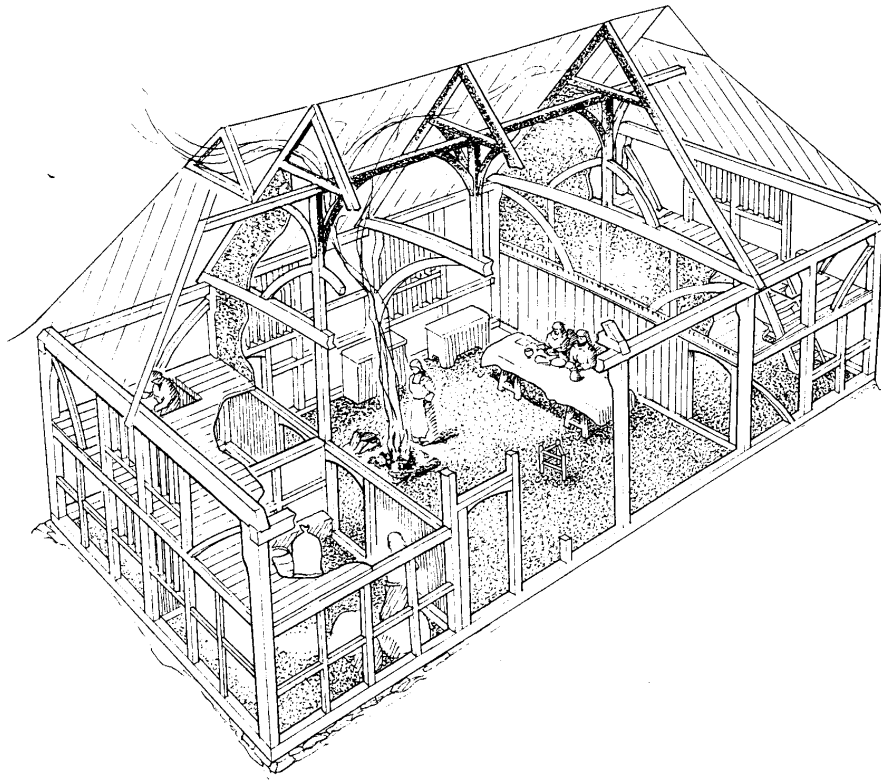
Fig 13 **A typical hall house** with a two-bay open hall and a crown-post roof. The high end is to the right with a parlour below and a 'solar' chamber above. To the left is the low end with two ground floor rooms, the pantry and buttery. The hall has the high table and an open hearth. The roof is hipped with gables, often used for the escape of smoke. Drawing by Gordon Simkin.

CROWN-POST ROOF: an often decorative but complicated roof structure. A single post rises from the centre of each tiebeam up to a central purlin running the length of the roof, and which carries the collars (fig 13). They are hard to visualise and are best seen. That at Wanborough Great Barn is spectacular (fig 15). Charlwood parish church has two, easy to visit. Godalming Museum, opposite the ‘pepper pot’ in the centre, has a fine example on public view. Details of these buildings can be found in the Gazetteer.

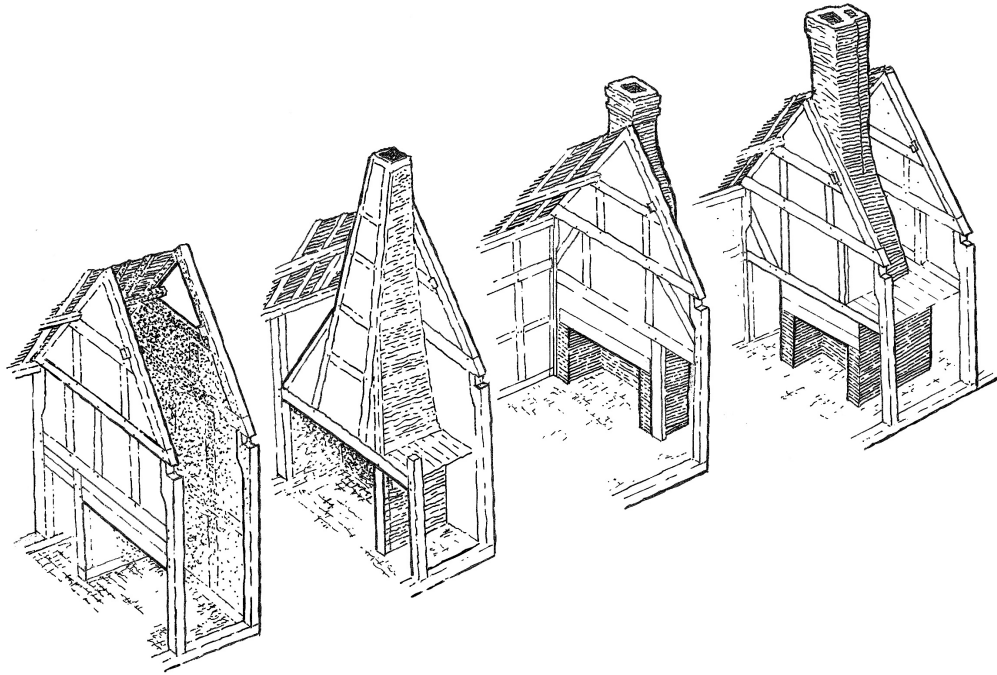
Fig 14 **Smoke control after the open hall.** From left to right: a smoke bay, a smoke hood, an external (end) chimney, a chimney within a half-bay (which can be an end or central chimney). Drawing by Martin Higgins after Harris (1993, 28).

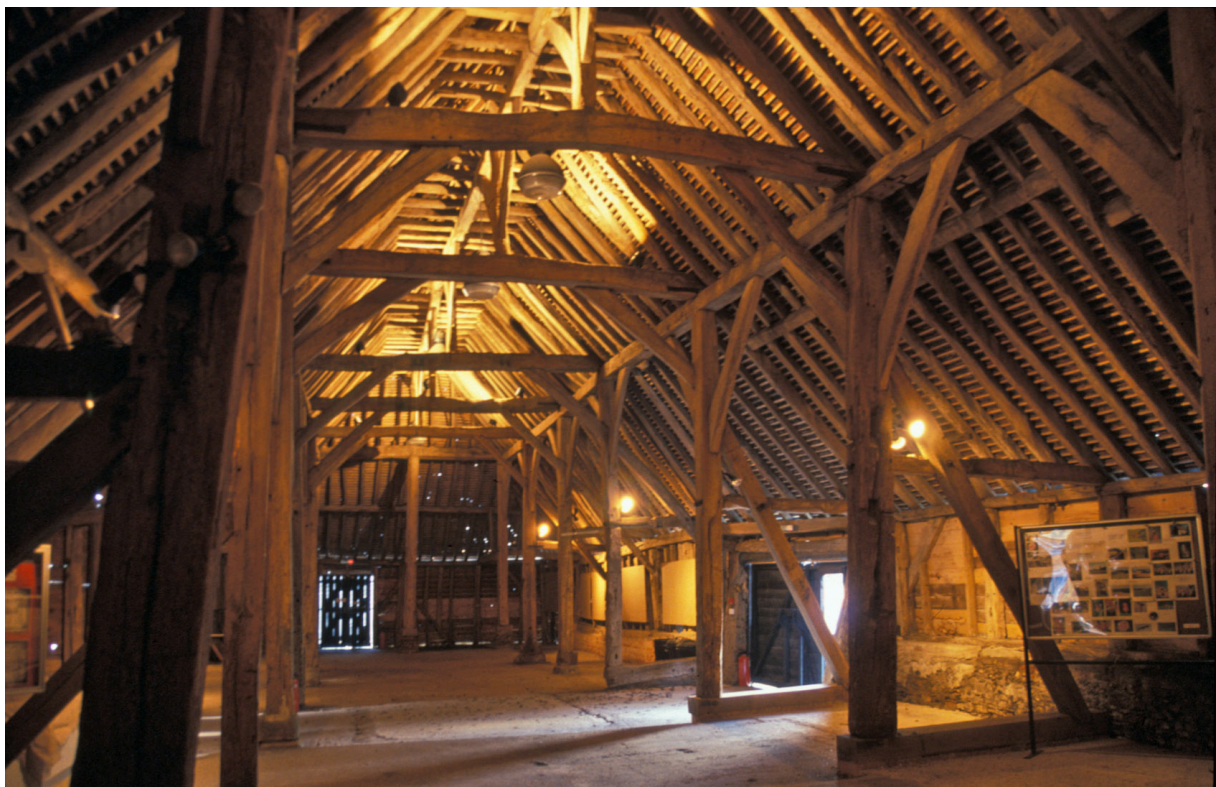
Fig 15 **Wanborough Great Barn, 1389**, a spectacular crown-post building often open to the public (contact Guildford Museum for opening times).

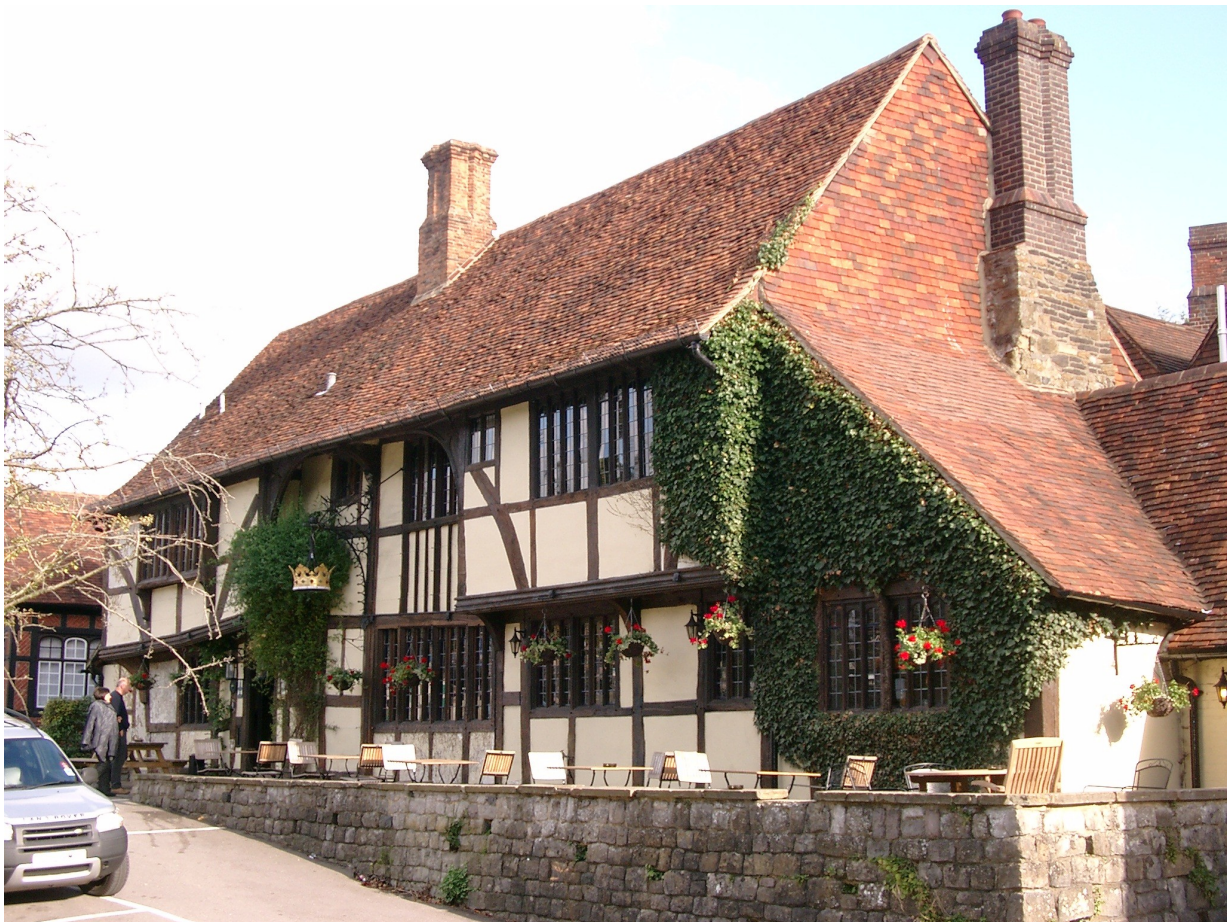
Fig 16 **Crown Inn, Chiddingfold, 1440**, perhaps the finest of Surrey’s Wealden-style houses with much to see in the public areas.

WEALDEN: an open-hall house in the Wealden style (figs 16, 22, 28). This is an impressive medieval fashion, with both ends jettied forward, but the roof plan is kept rectangular by means of a flying wall plate over the front of a recessed centre.

The attractive ‘Wealden’ style of house (figs 16, 28) has been discussed in Part 2. Most have two-

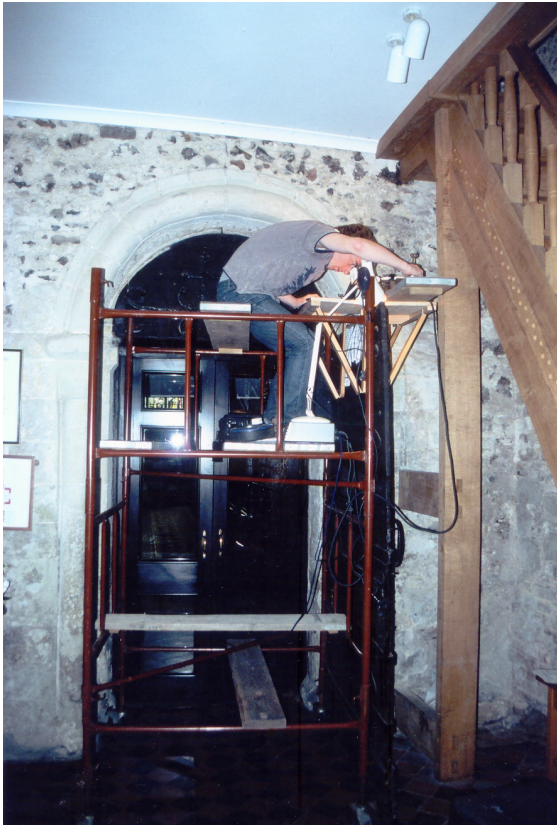
Fig 18 **Great Door at St Peter's church, Old Woking.** Andy Moir measuring the tree rings, having sanded down the top edge to expose them.

The Project team is always being asked what was the earliest dating found. It was in one of these non-domestic buildings, not the building itself, but a door. St Peter's church in Old Woking has a remarkable door with ornate C-straps and rare medieval ironwork (Geddes 1999). Originally, it had a rounded top in the Norman style that has been cut off at some time, but remains in place, unhinged. The main door is made up of four great oak planks of differing widths, and there had been speculation that the door could be Norman in date. Such planks could not be cored in the usual manner, so the dendrochronologist, with great ingenuity, set up a scaffold tower and sanded the top edge, exposing the tree rings. With the aid of a special jig and a travelling microscope, he measured the ring widths *in situ*. It was thrilling when a Norman date was indeed found, within the range 1106–38. In this case the extra precision of a 'modal value' is justified (see 'Dates in the text' in Part 1). The calculation gives a most likely date of 1114, just a few years into the reign of Henry I, William the Conqueror's third son. There are more details, including a comparison with other ancient doors, in Part 4, the Gazetteer (listed under Woking).

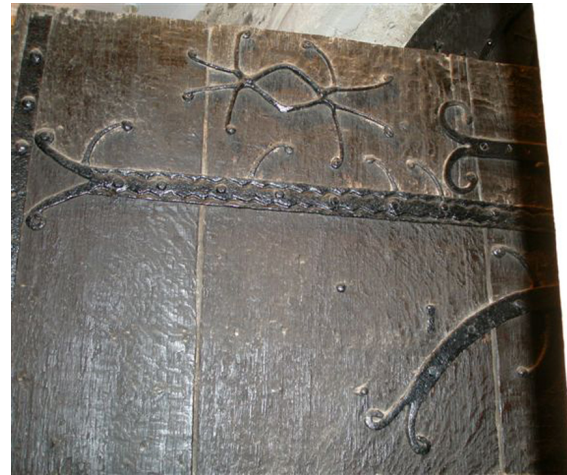
Fig 19 **St Peter's church, Old Woking.** Top part of the Norman door.

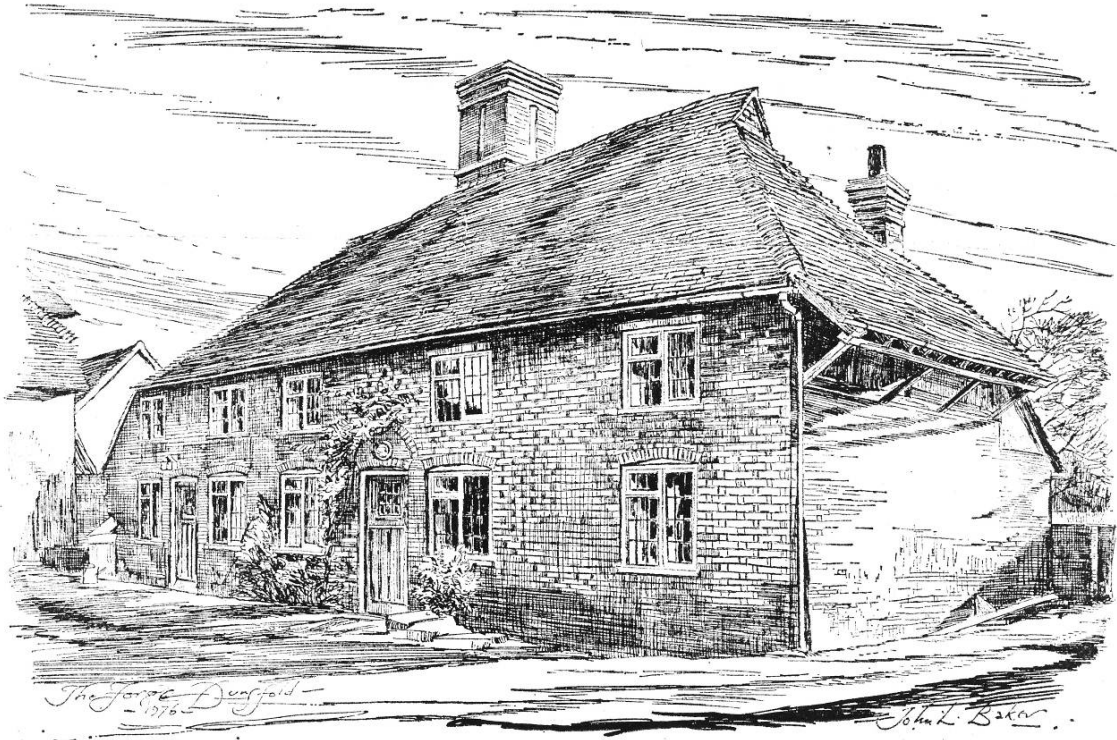
Fig 20 **Forge Cottage, Dunsfold, 1254**, Surrey's earliest dated house. Georgian brickwork conceals an ancient aisled hall. The illustration shows how the roof at the rear comes down over the remaining aisle to little more than head height. Drawing by John L Baker, reproduced courtesy of the *Surrey Advertiser*.

Houses surviving from the 13th century are rare indeed, but the Project found one, Forge Cottage, Dunsfold, and dated it at 1254. It is now encased in Georgian brick and only the high roof hints at its age. Inside, it is an exemplar in very early carpentry. It was aisled, with one of the carved arcade posts remaining. The roof is scissor-braced. Investigation uncovered evidence of dragon ties, parallel duplicate bracing, notched lap joints, horizontal spandrel struts, heavy straight square-section braces, and much more. It stands inconspicuously on the Green next to the public house, unnoticed by most, while archaeologists marvel at its survival (fig 20).

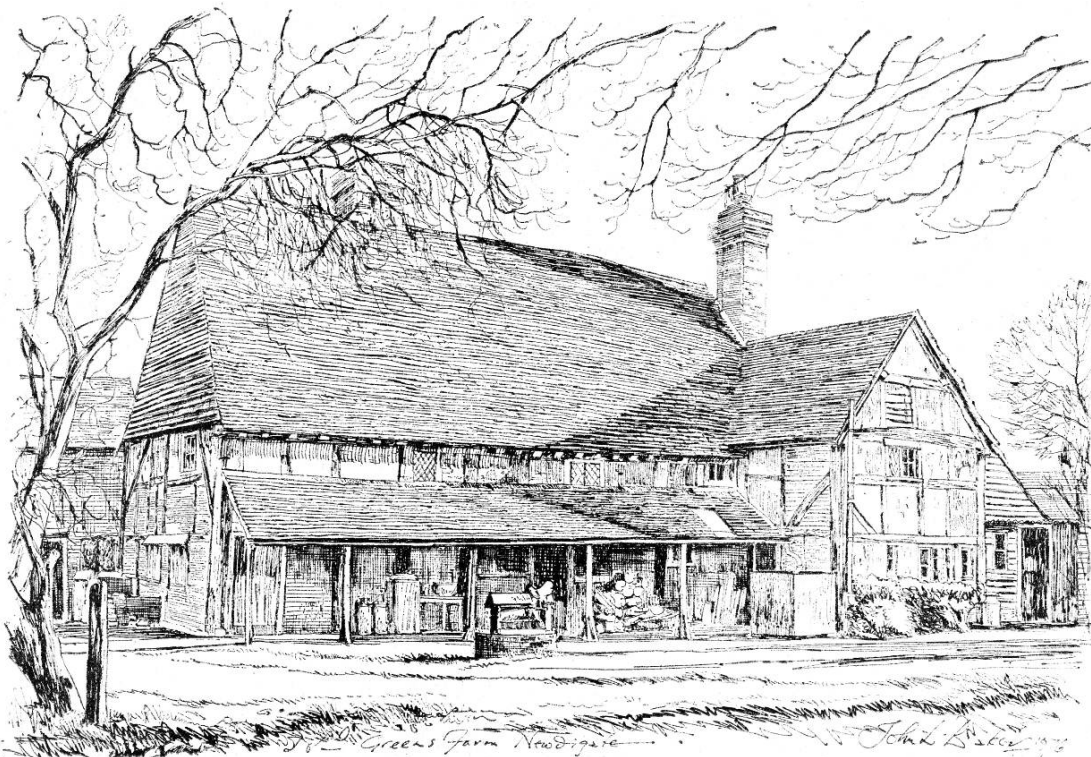
Fig 21 **Greens Farm, Newdigate, 1309**, with a soaring roof and giant crown posts - the earliest such posts dated by the Project. The wing to the right is newer, as is the chimney and pentice roof along the front. Drawing by John L Baker, reproduced courtesy of the *Surrey Advertiser*.

The Project then progressed northwards up the Mole Valley to Capel and Newdigate. The old houses in this area seem to have been more expensively built. Ivy House, Newdigate, 1518, has a rare plank-and-muntin dais screen and chamfered wall plates. Taylors, Capel, 1467m, (fig 29) has another plank-and-muntin screen, as well as a moulded dais beam as fine as can be found anywhere. The 1400 barrier was well and truly breached here, with five houses before that date. The tiny Ketleas, Capel, c 1389, just 8m long, is a surprising survival but the grandest of them all is Greens Farm, Newdigate, 1309 (fig 21). This is a

The 14th century saw more domestic dwellings built to last and indeed surviving to this day. They are all open-hall houses, but we do see the introduction of the crown-post roof. At last, medieval carpenters had found a way to brace the rafters against each other without relying on the battens to keep them apart. In many parts of England, the crown post appeared just before 1300, but the earliest dated example in Surrey is Greens Farm, Newdigate, 1309 (fig 21).

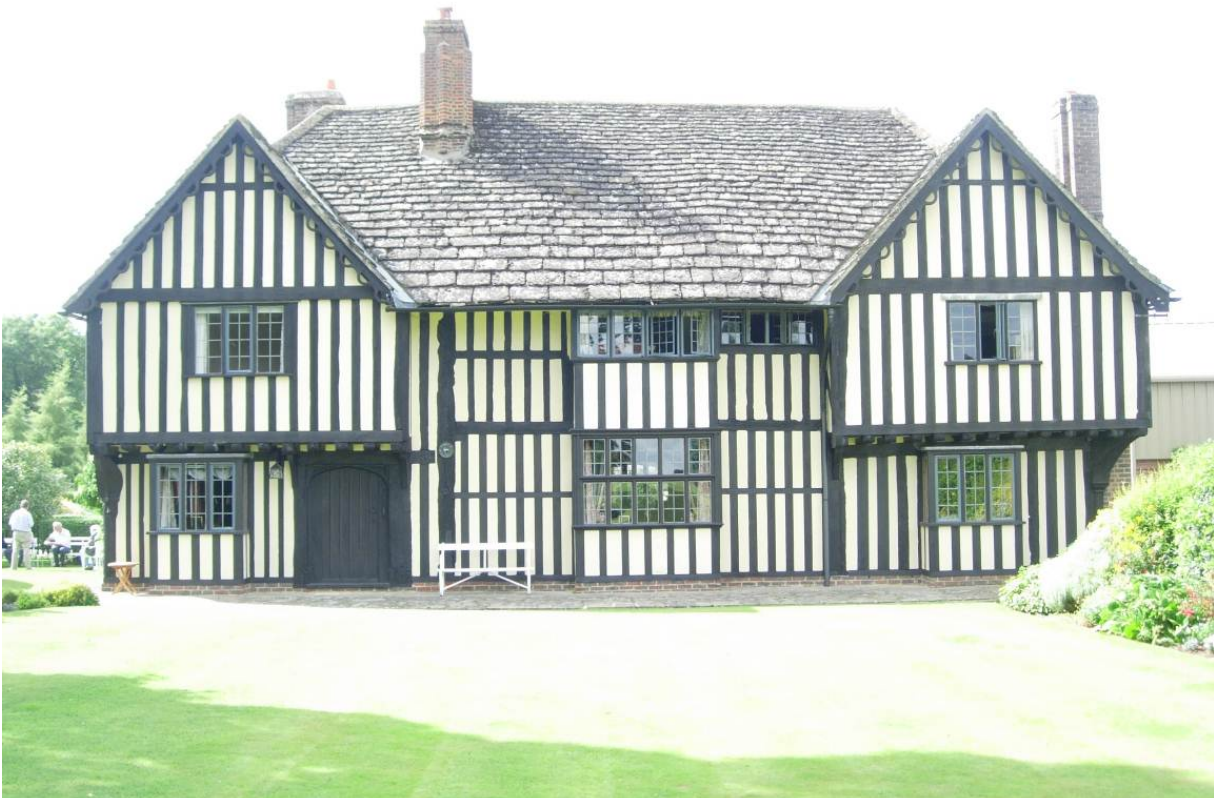
Fig 22 **Brewerstreet Farmhouse, Bletchingley, 1491**, a variant Wealden house of unusual riches and design. Note the forward-facing gables, full-height close studding, ‘Horsham’ stone roof, ornamental barge boards and arched doorhead. The farmhouse was rescued from dilapidation by the owner. Photograph by Patrick Moyle.

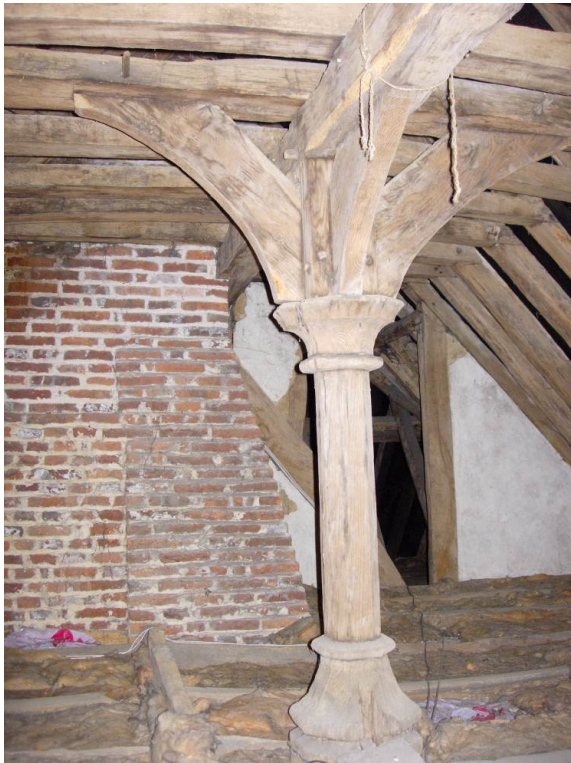
Fig 23 **The open-truss crown post at Brewerstreet Farmhouse, Bletchingley**, is particularly fine with an octagonal shaft, base and capital. Photograph by Patrick Moyle.

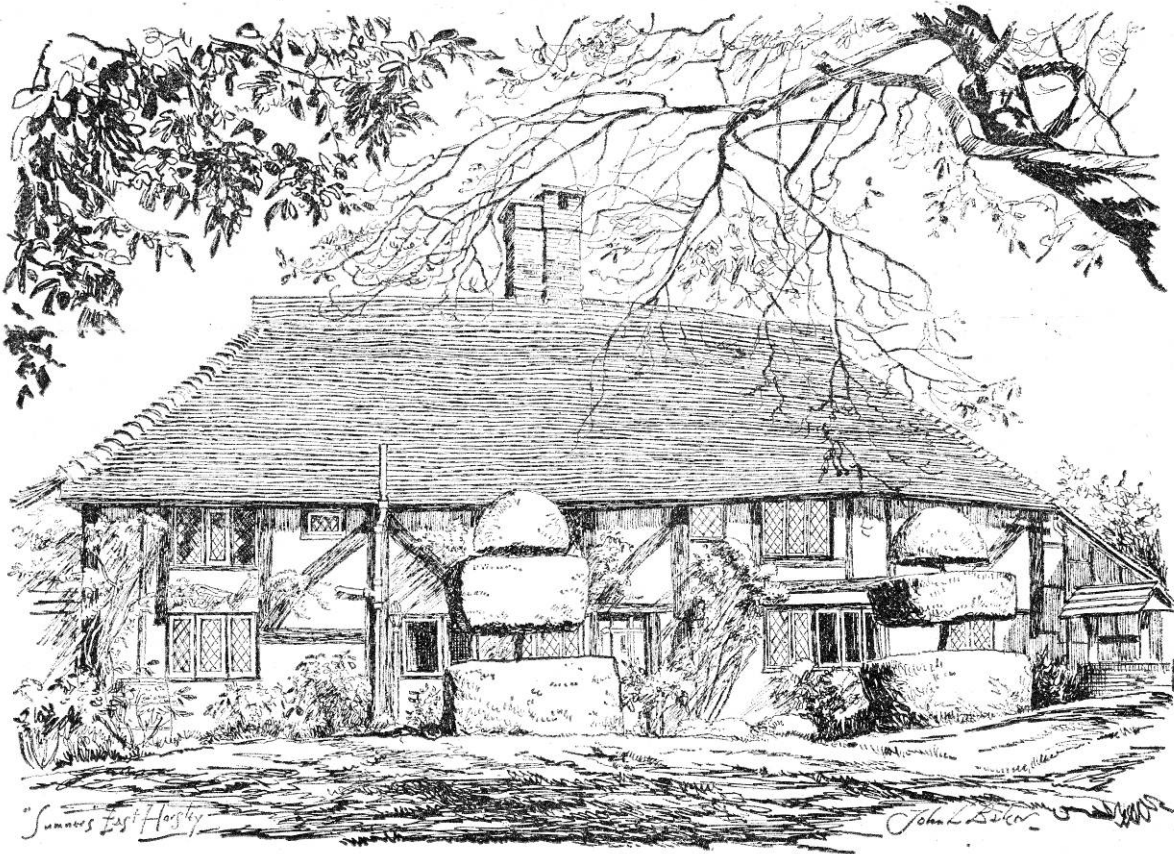
Fig 24 **Sumners, West Horsley, 1449**, appears to be a typical medieval open-hall house. They usually sit ‘fat and comfortable’ in the landscape. It has quite low walls, but an expansive roof with a fairly steep pitch, hipped at both ends with gables. Later buildings often give the impression of being ‘tall and narrow’. In detail, the house is less typical. There are down braces rather than arch braces – quite innovative at such an early date. In contrast, the roof is quite antiquated. It is not crown posted, as would be expected. It is a ‘common-rafter’ roof, a very simple construction rarely found at such a late date in a house of this quality. Only the battens stop the rafters from falling over. Drawing by John L Baker, reproduced courtesy of the *Surrey Advertiser*.

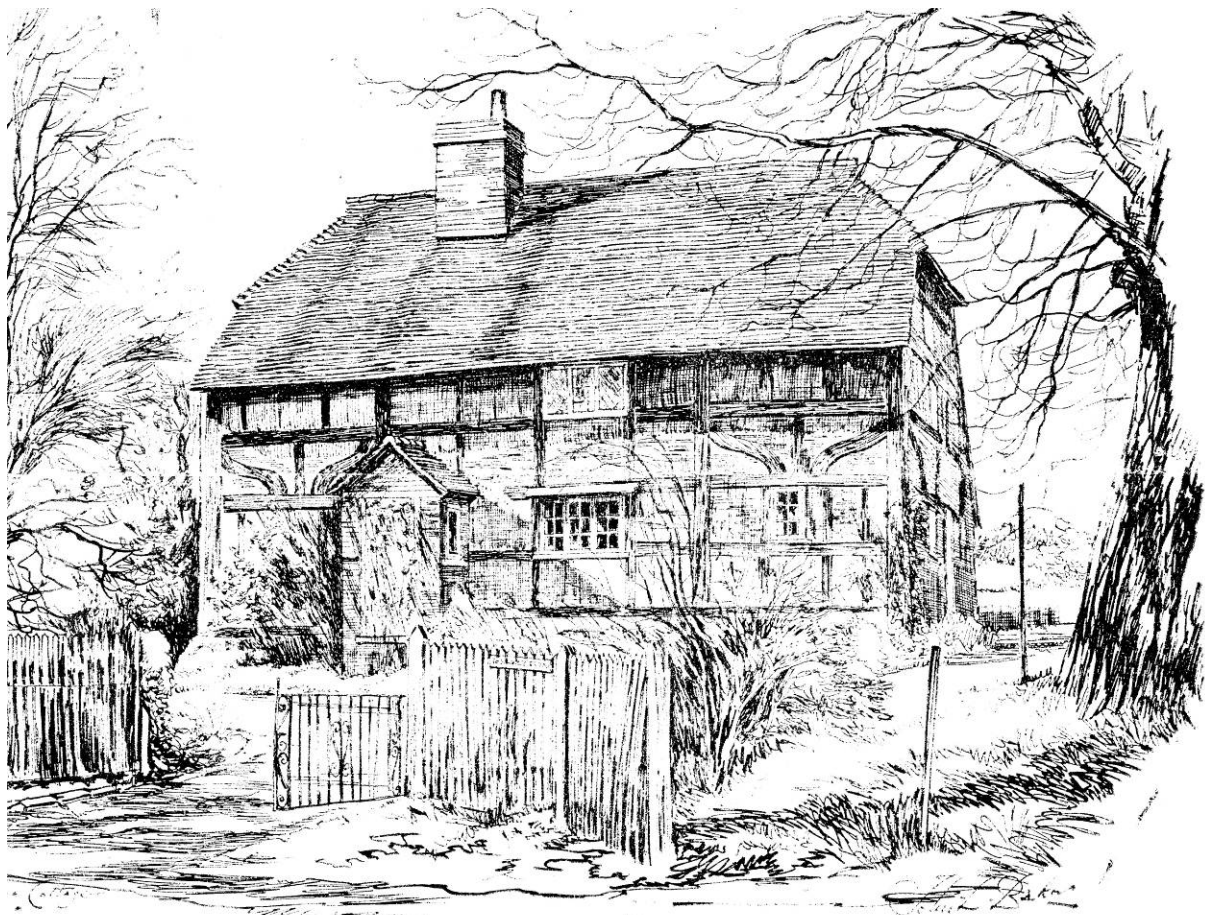
Fig 25 **Tunmore Cottage, East Clandon, 1573**, is an example of the transitional type of 16th century house on the way to a proper brick chimney. It has a smoke hood, a type of timber-framed chimney, in this case in the half-bay behind the porch, in the framing that now contains the later brick chimney. Notice the small, square panels, coming into fashion about this time, and the fine ogee braces, of which there are twelve, beautifully matched all round the building. Drawing by John L Baker, reproduced courtesy of the *Surrey Advertiser*.

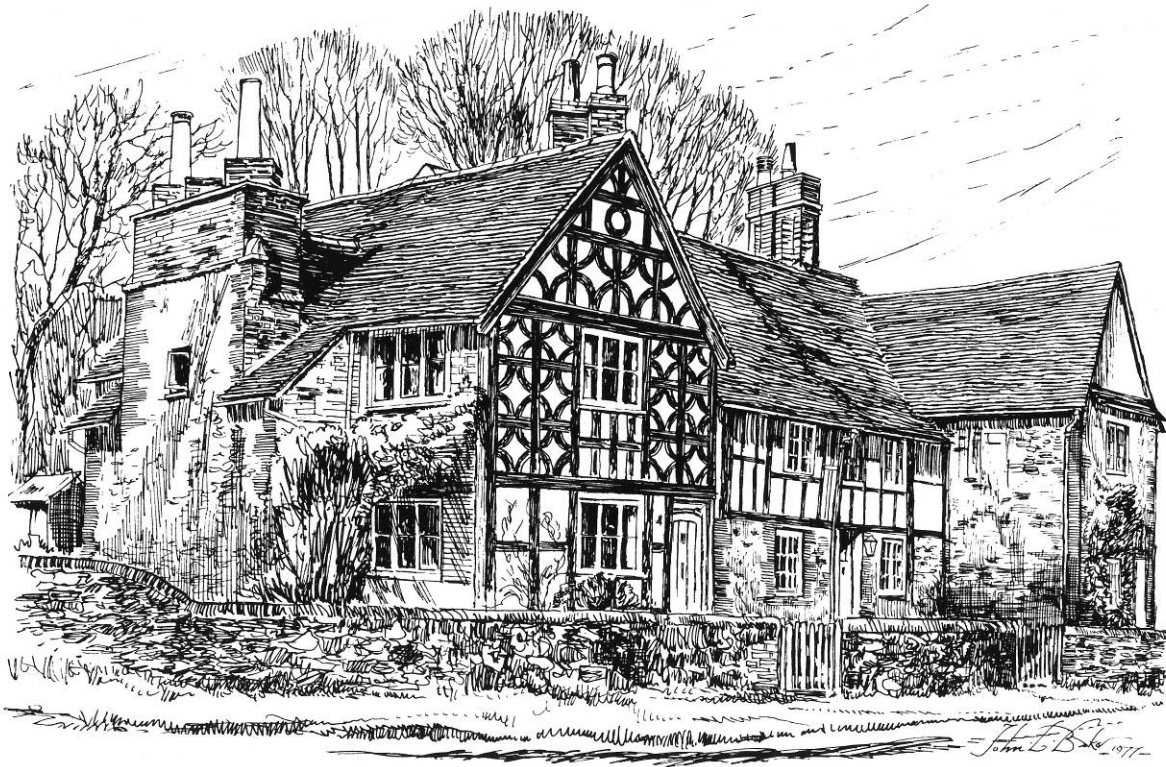
Fig 26 **Malthouse Cottages, Gomshall** (Shere parish), 1581, shows a very decorative style that flowered briefly in Elizabeth's reign. Drawing by John L Baker, reproduced courtesy of the *Surrey Advertiser*.

‘Durn doors’ have pointed doorheads, with the whole frame made up of just two timbers arching inwards to meet at the top. They are a rare early feature and are discussed in ‘Very Early Buildings’ below. Less rare, but still not frequent, are arched doorheads with ‘depressed arches’ – usually the four-centred ‘Tudor’ type. Surrey examples are spread quite evenly throughout the 15th century and into the 16th century. They are a sign of wealth, rather than date, and occur in open-hall houses. A fine Wealden-style house in Farnham (80–81 West Street, 1467) has three examples, one with hollow chamfering around the arch and down the posts. There are just two late examples in early chimney houses: Barlings parlour wing, Farnham, 1547, and Malthouse Cottages, Gomshall, 1581 (fig 26).

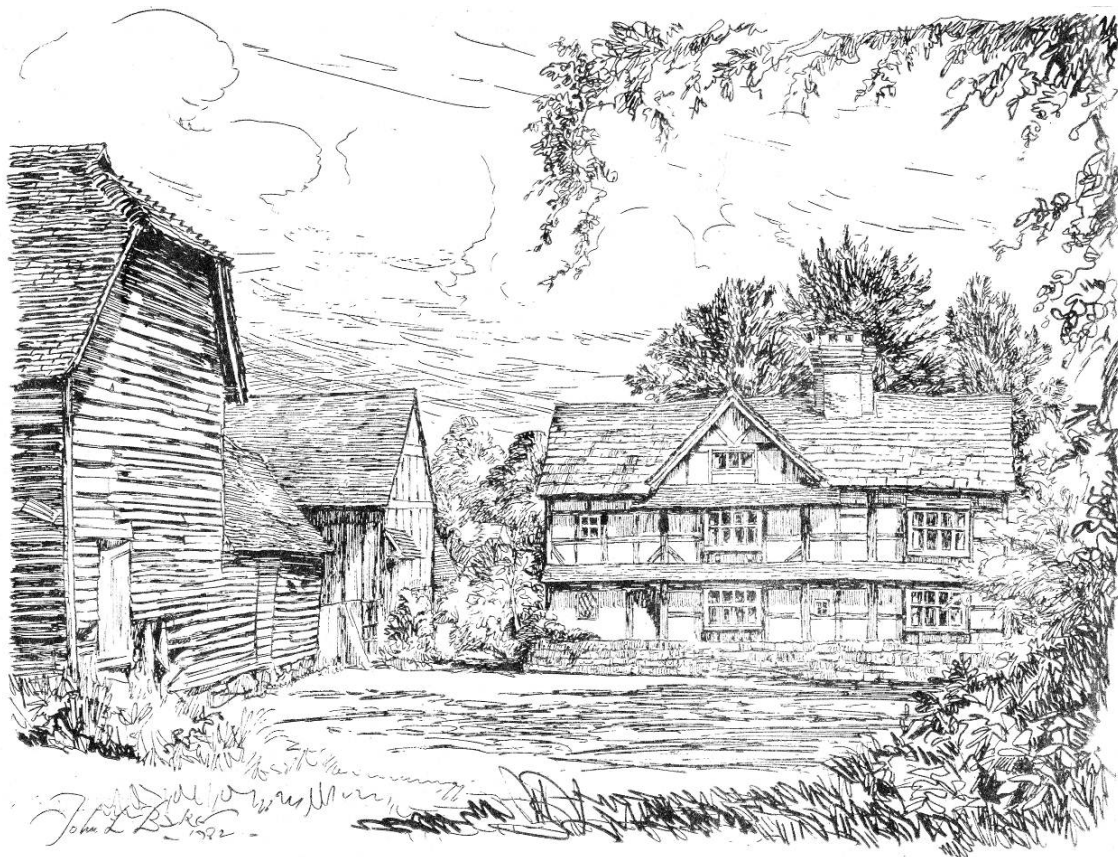
Fig 27 **Volvens, near Ockley** (Abinger parish) 1623. A textbook example of a higher-status 17th century house, with a central chimney, a forward-facing gable, small square panels with short straight braces, oriel windows and a pentice roof. Drawing by John L. Baker, reproduced courtesy of the *Surrey Advertiser*.

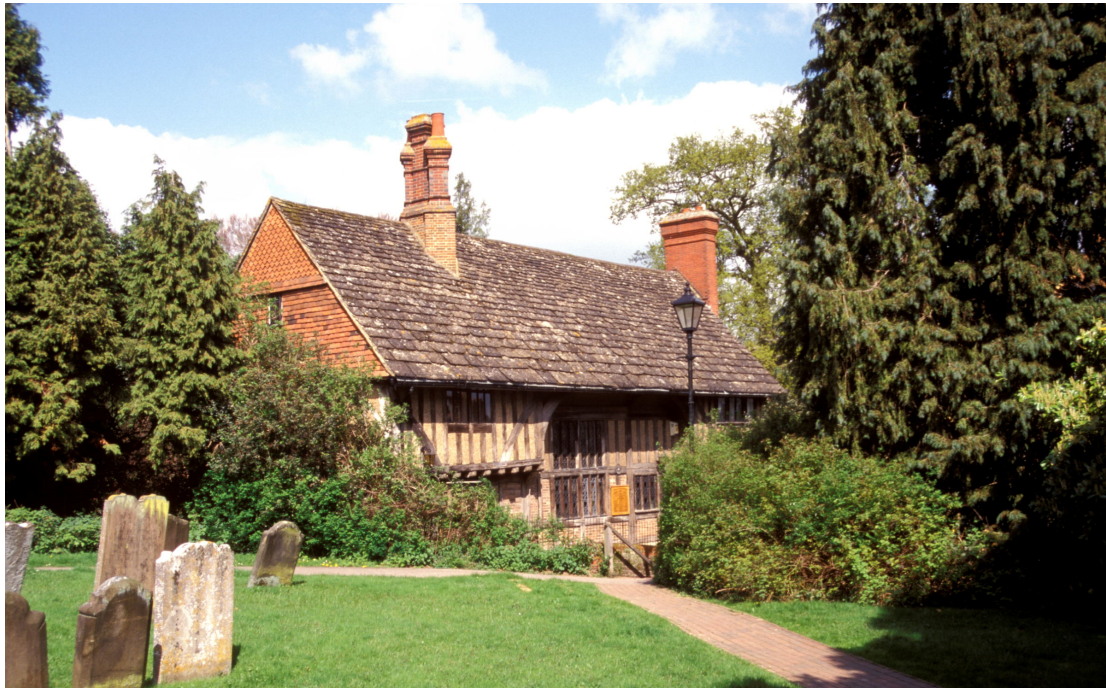
Fig 28 **The Guest House, Lingfield, 1474**, is a stunning example of the pleasures of traditional timber-framed buildings. It is in the Wealden style, with jetties, a bridged-over centre, close studding, and a Horsham stone roof. It may have been the hospitium for a monastic college. The interior is just as beautiful, with a rich open truss. It is a public library, so open to all. It has been restored, but the masterful carpentry shines through.

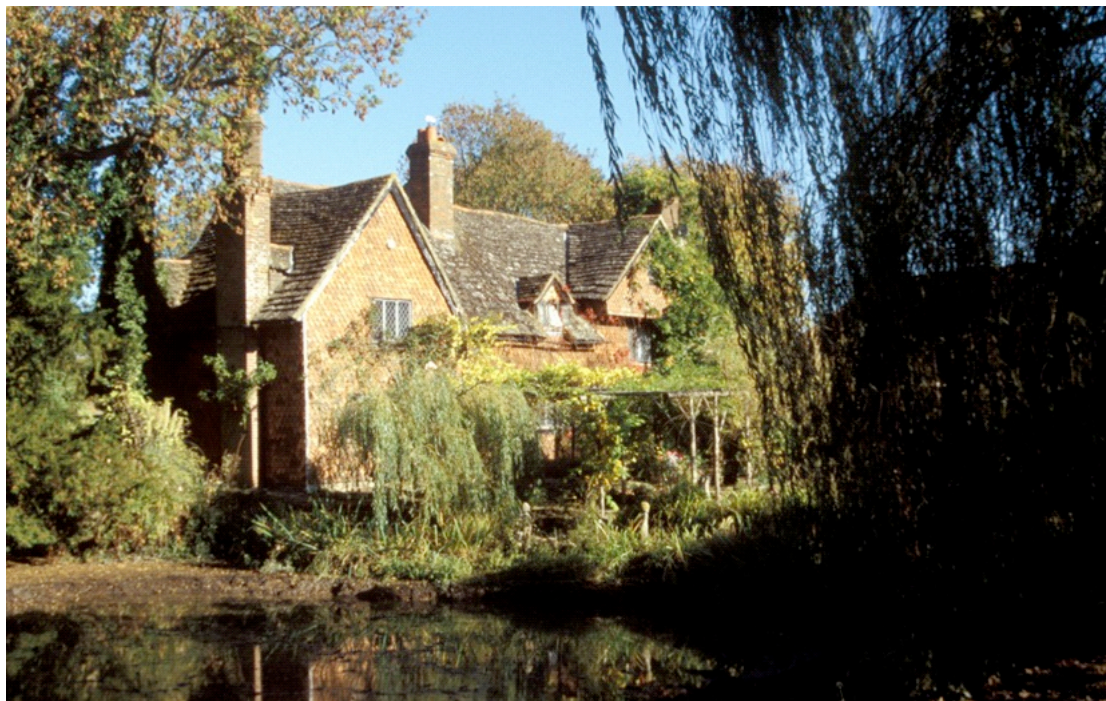
Fig 29 **Taylors, Capel**, has pleasures of a different kind. It is extraordinarily picturesque and needed a combination of archaeology and dendrochronology to unravel its history: west wing (left), 1345; centre part, 1467m; east wing, 1642m. The Horsham stone roof and tile-hanging are very 'Surrey'.
