THE DEVELOPMENT OF TIMBER FRAMING IN SURREY'S OLD BUILDINGS

An analysis and calibration by means of tree-ring dating

Rod Wild and Andy Moir

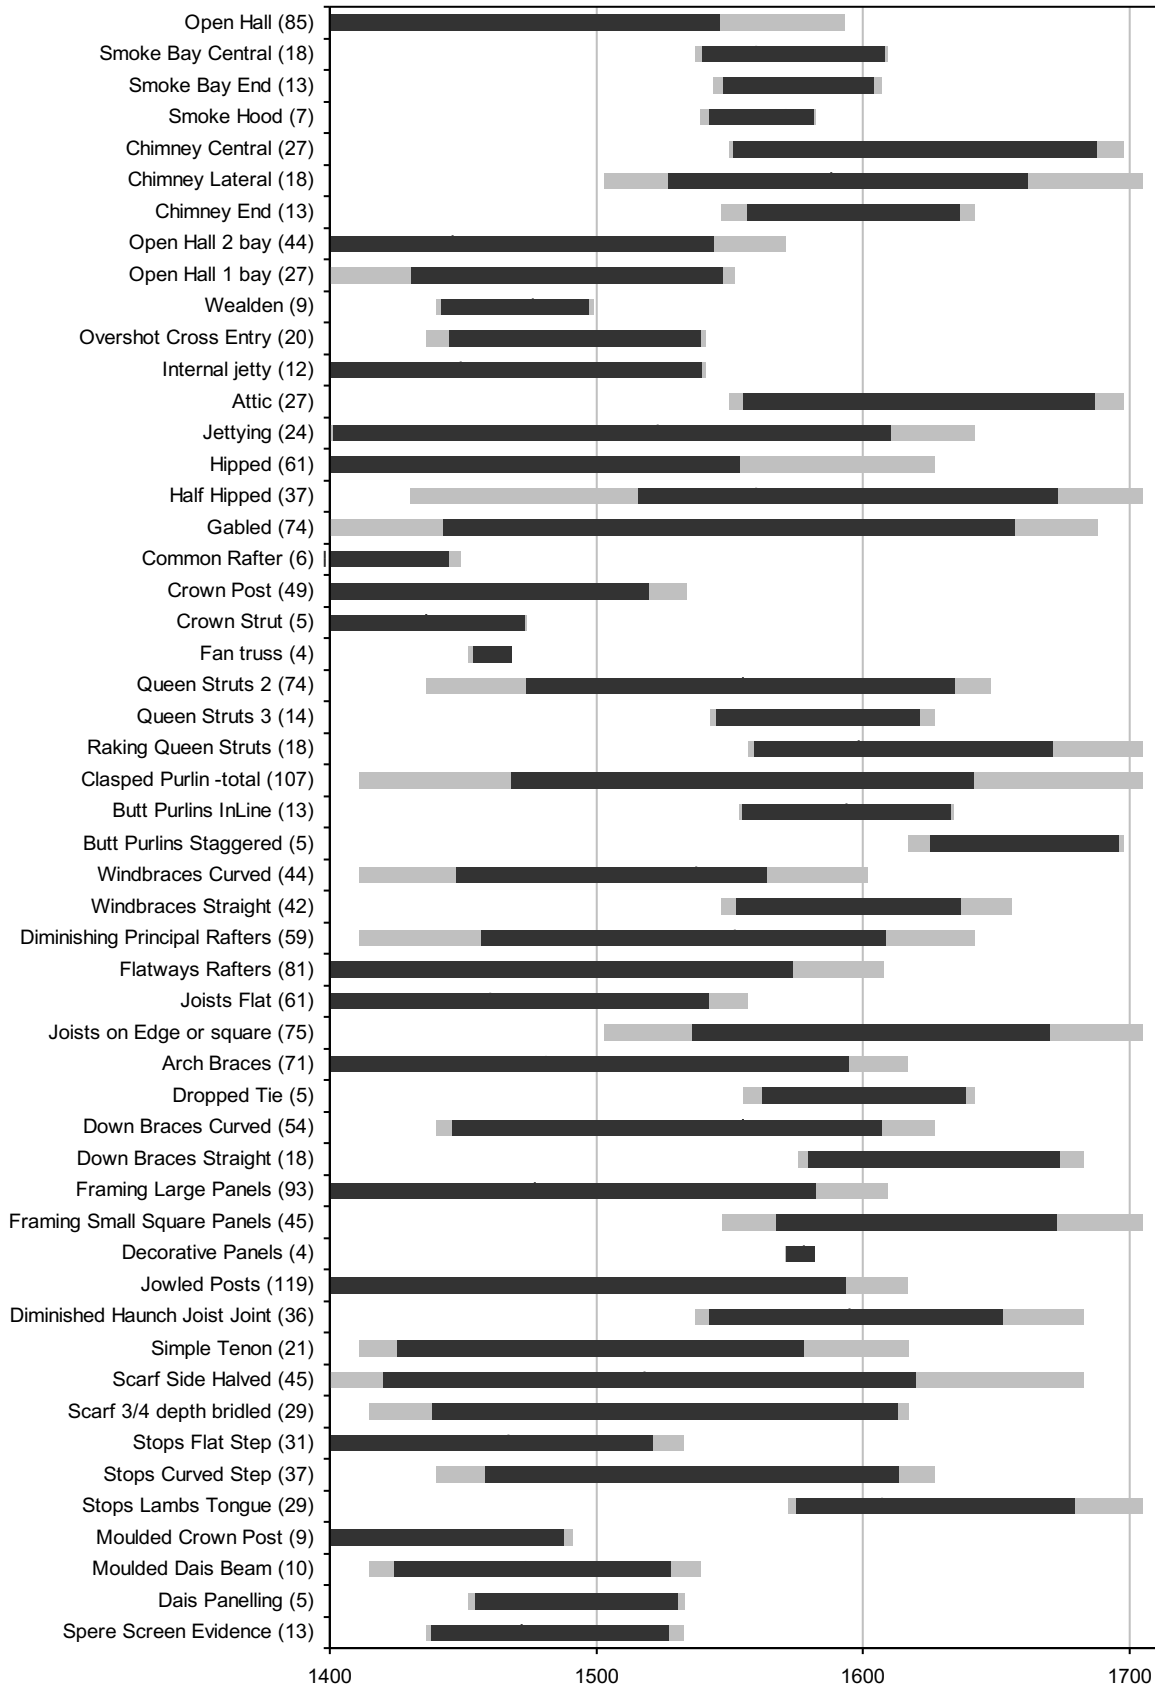
Fig 31 **Summary date spans for the Project’s main key features** for the 177 dwellings and additions to existing dwellings. The dark range shown is between the 4th and 96th percentiles so as to encompass at least 90% of the data whilst eliminating outliers. The total range of data is represented by the lighter shade. It does not cover pre-1400 features, examined separately.

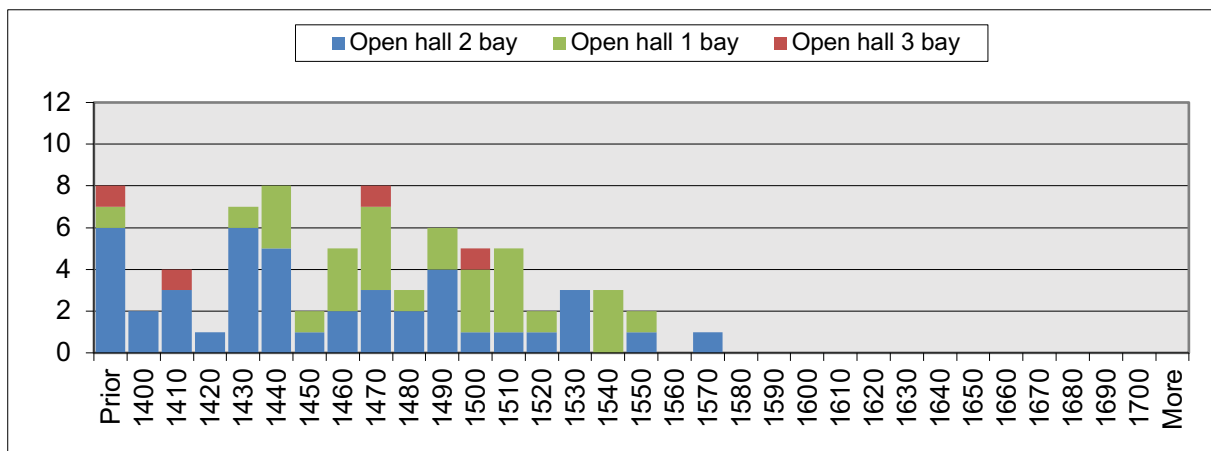
Fig 33 **Dates for open halls of various sizes.** With rare exceptions, the one-bay open hall does not start to be used until about 1440.

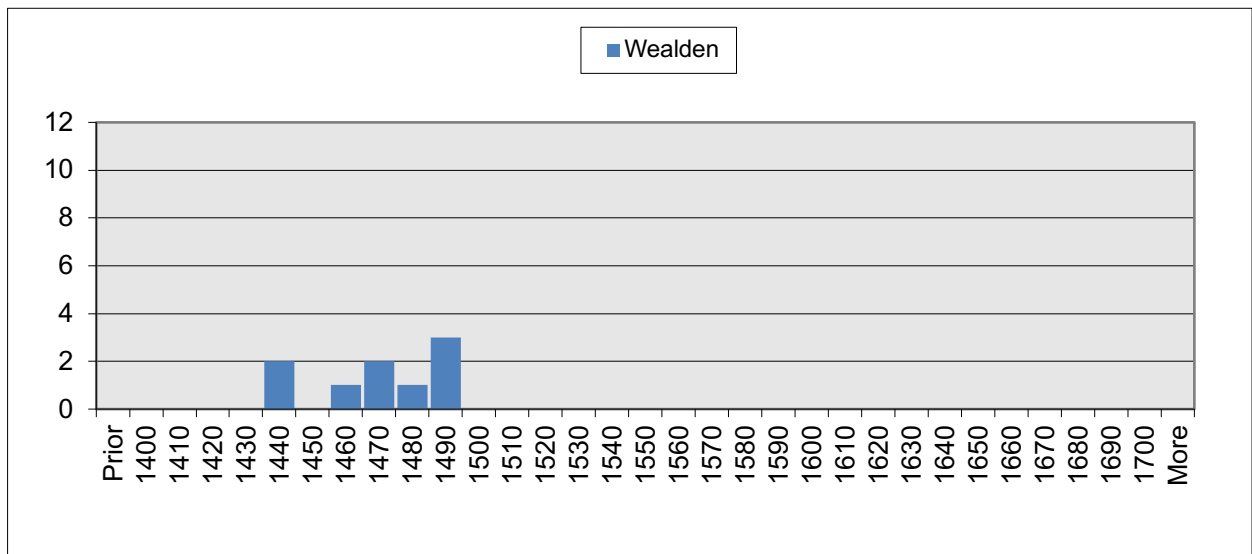
Fig 36 **Dates for Wealden-style houses.** These dates are a little later than in neighbouring counties. The sharp cut-off at 1500 is remarkable.

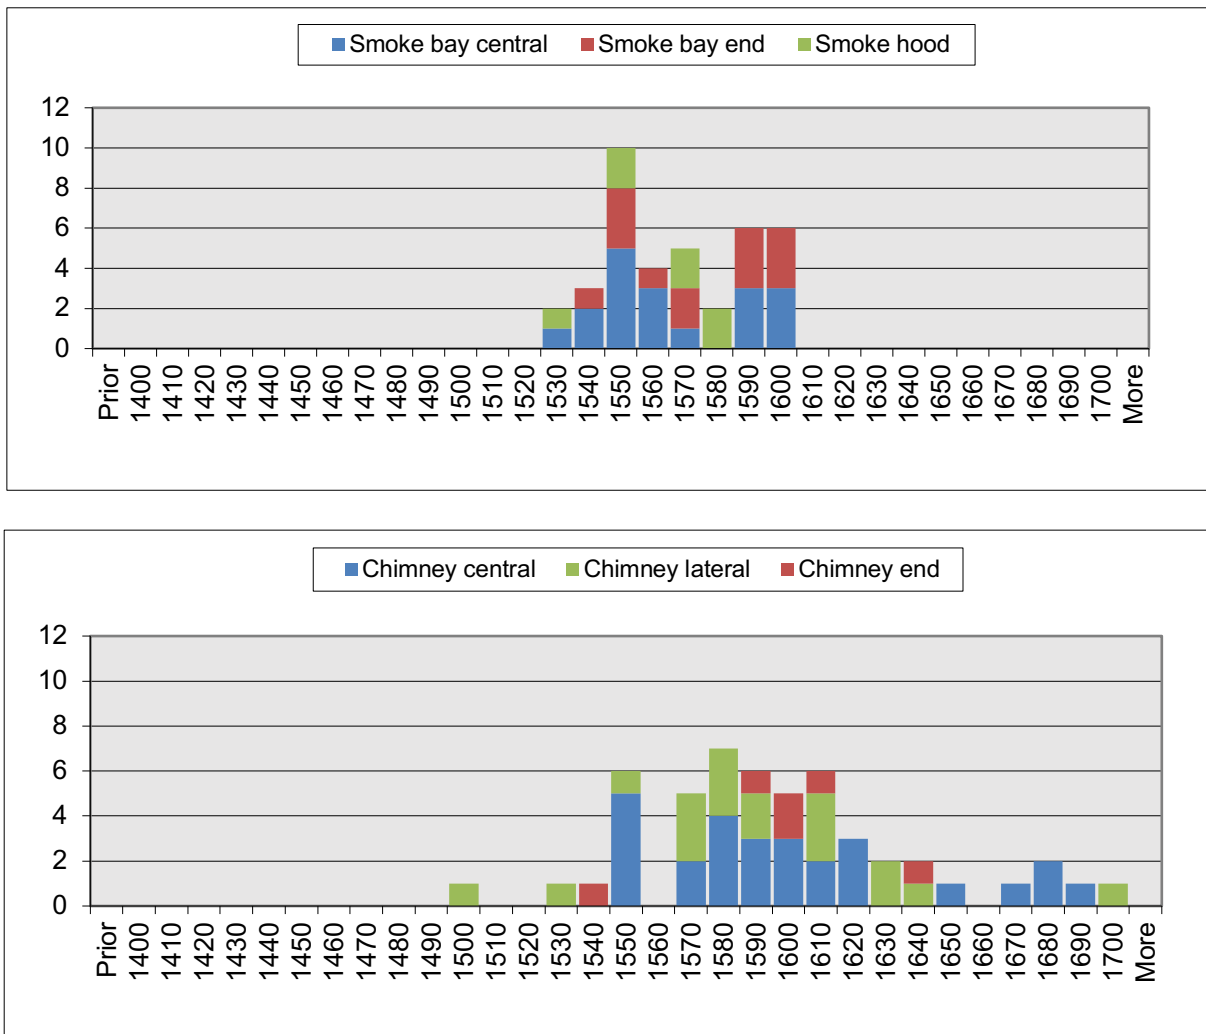
Fig 37 **Dates for the methods of smoke control after open halls.** For smoke bays, there is a tight range, starting about 1540 and ending abruptly soon after 1600. Chimneys started to be used about the same time and were equally popular - it was a matter of wealth - until brick became readily available about 1600.

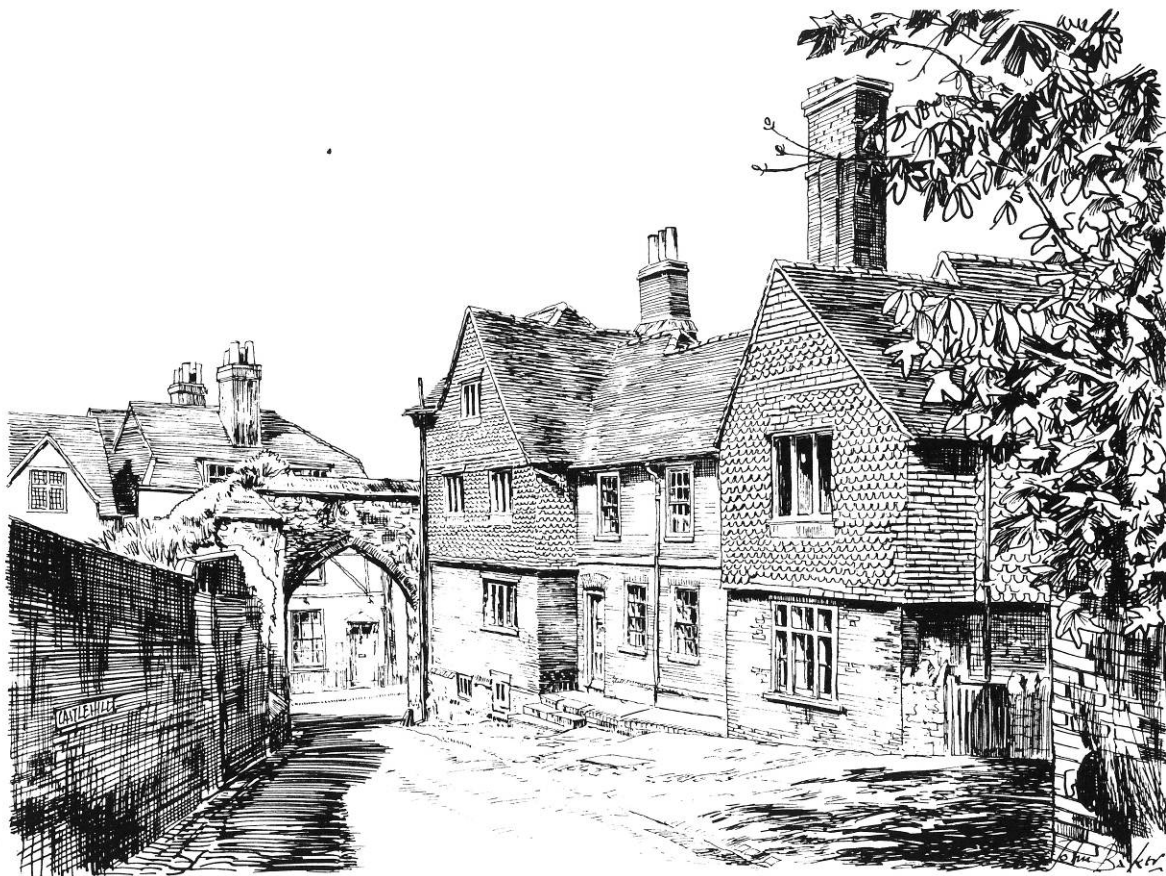
Fig 39 **Castle Arch Guildford, 1554**, an early chimney house, now home to Guildford Museum. The tree-ring dating was obtained from the roof timbers, and applies only to the centre range, not the later wings. Drawing by John L Baker, reproduced courtesy of the *Surrey Advertiser*.

After these few early examples, chimney houses came quickly in the 1550s (fig 37). One of these is Castle Arch, Guildford, 1554 (fig 39). This date – for an important museum building – was a local success for the Project, being much earlier than the previous estimate of *c* 1630. (The error in the earlier stylistic estimate can be excused by a confusing amount of re-facing in brick). The tree-ring date was obtained from the roof timbers, and applies only to the centre range, not the later wings.

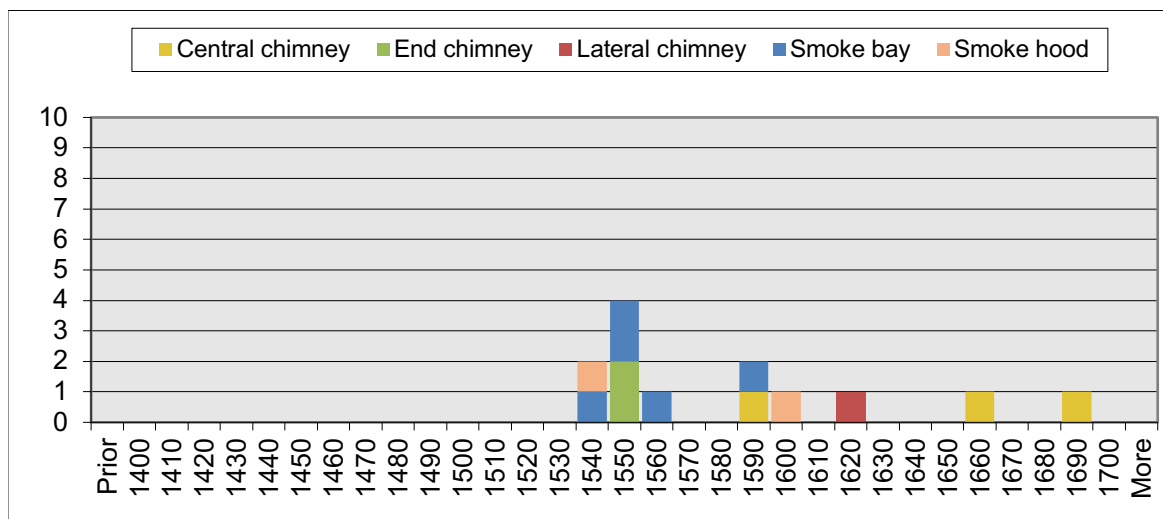
Fig 41 **Dates for inserted smoke control methods.** These cover the sequence: open hall to smoke bay to chimney, and the dates for converting, sometimes missing a step. It is surprising how long the process took.

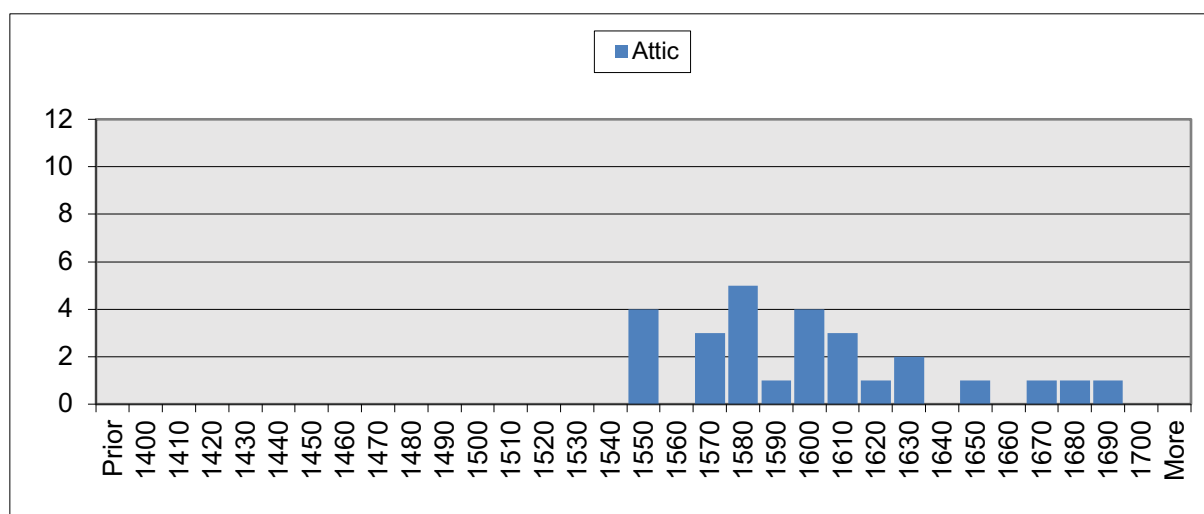
Fig 42 **Dates for buildings with attics from the beginning.** This is another example of the ‘1540 changes’, made possible by the more unobstructed roof spaces of the side-purlin method of roof construction.

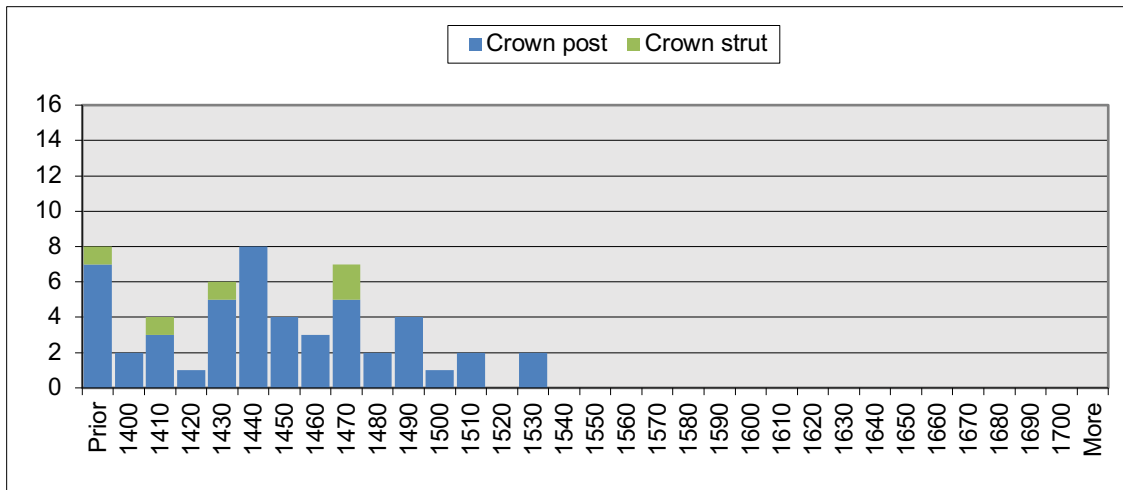
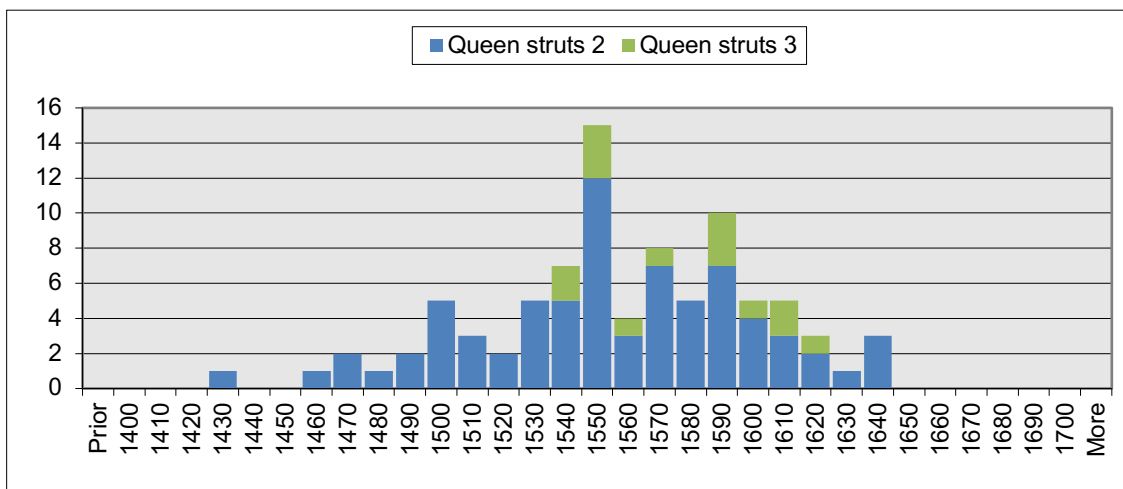
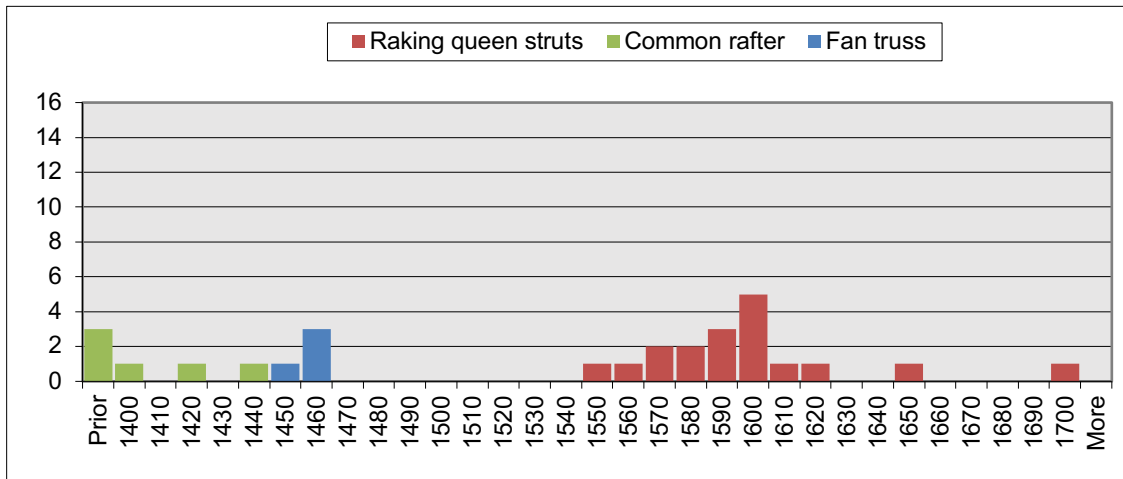
Fig 45 **Dates for various types of roof truss.** The three main types are crown post, queen struts 2 and raking queen strut. The sequence can be seen, with the change to queen strut at about 1500 and then the beginnings of the raking queen strut about 1570.

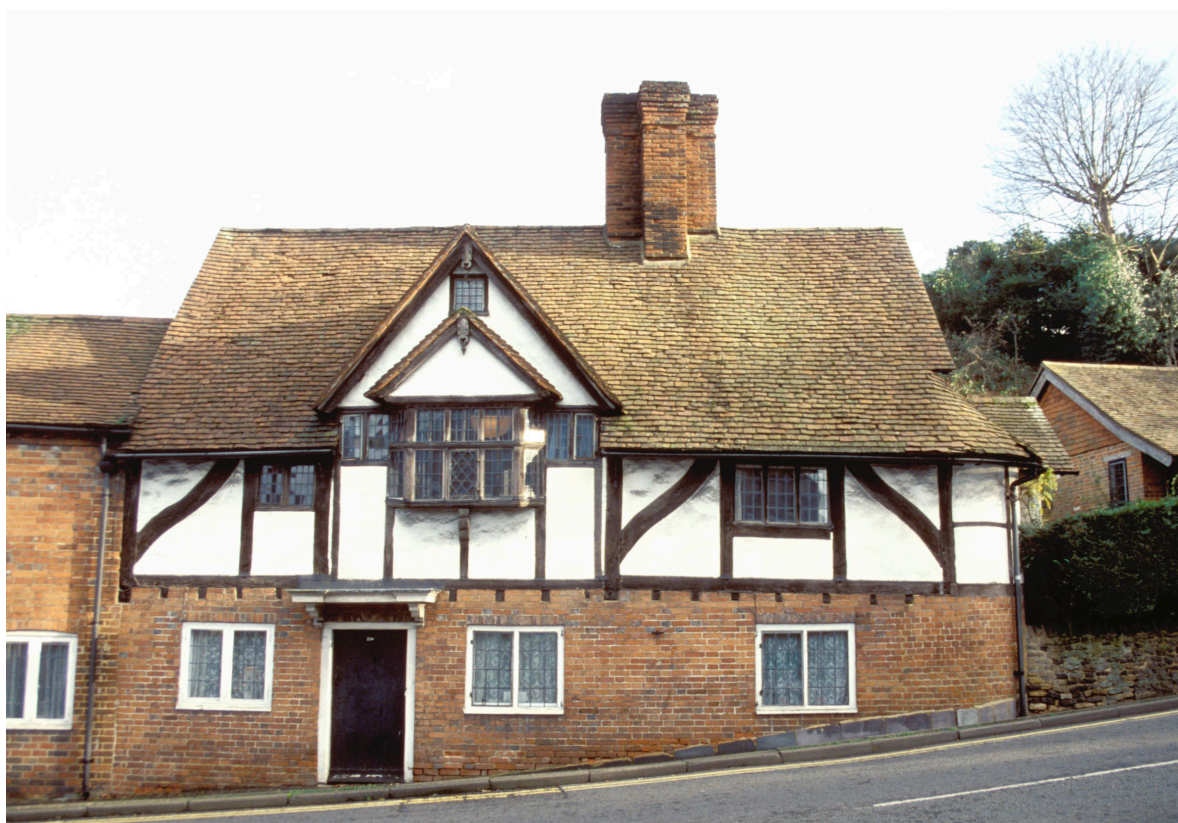
Fig 46 **11 Bridge Square, Farnham, 1476**, is a well-disguised Wealden-style house, the jetties having been under-built and the recessed centre filled in. A forward-facing gable was added, with a remarkably-carved oriel window, now very much a feature of the house. It is unusual in a number of ways: a half-floored hall (discussed above); attractive ogee braces; and a roof of clasped-purlin construction – at this date elsewhere in Surrey it would have crown posts.

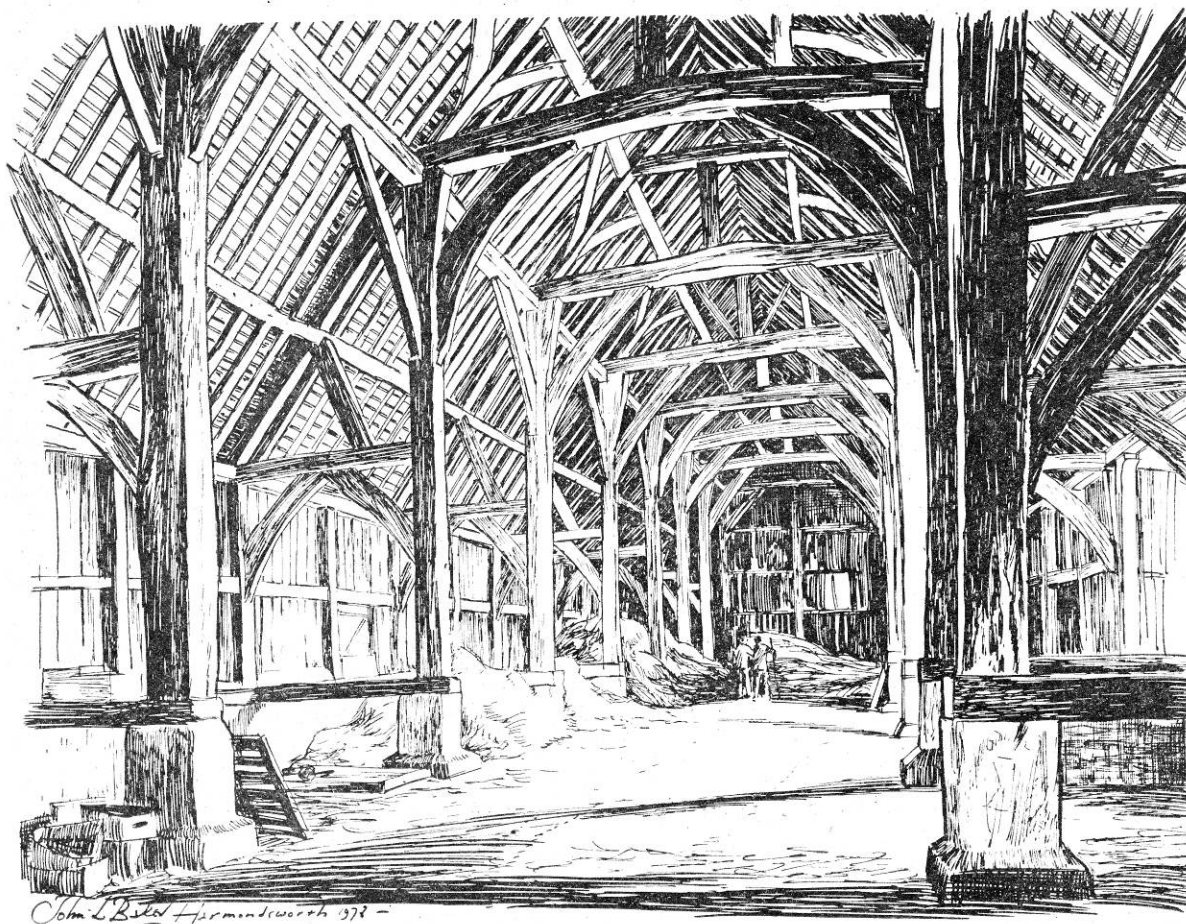
Fig 47 **The Great Barn, Harmondsworth, 1426**, is a magnificent barn linked to William of Wykeham, Bishop of Winchester (Impey 2017, 13). The structure is pioneering, with single central crown struts, forming 'T' shapes with their collars in the roof. The struts are like crown posts, but there is no central collar purlin joining their tops along the length of the building. Instead the collars hold in place side purlins, quite new and much more efficient. Drawing by John L Baker, reproduced courtesy of the *Surrey Advertiser*.

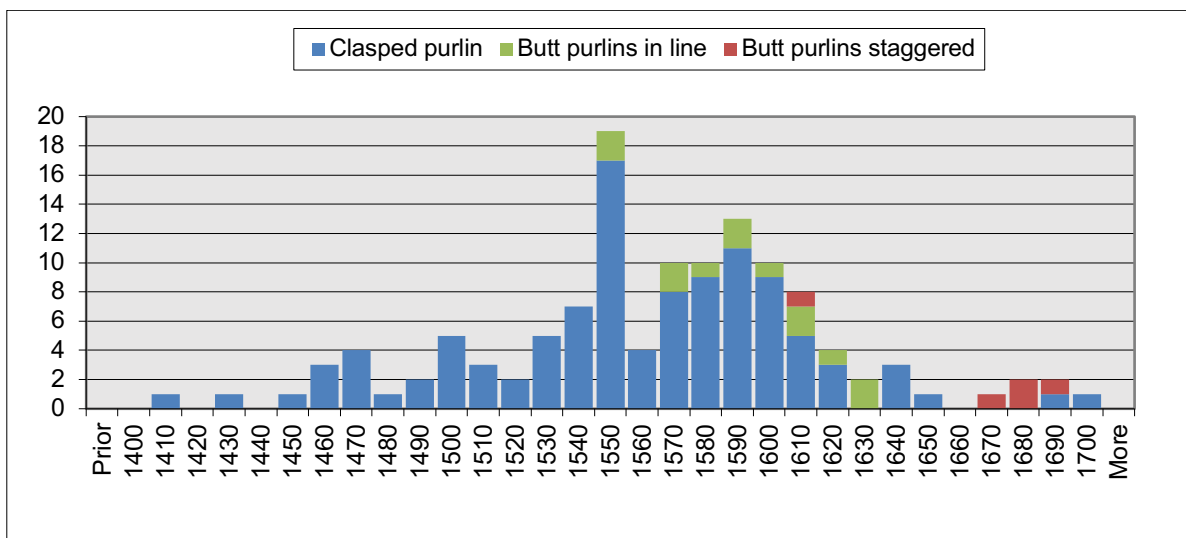
Fig 50 **Dates for the main types of roof framing.** After crown posts, clasped purlins dominated, with just a few butt-purlin roofs in higher-status or larger buildings. Later, the staggered type of butt purlin became the more popular and common at all levels.

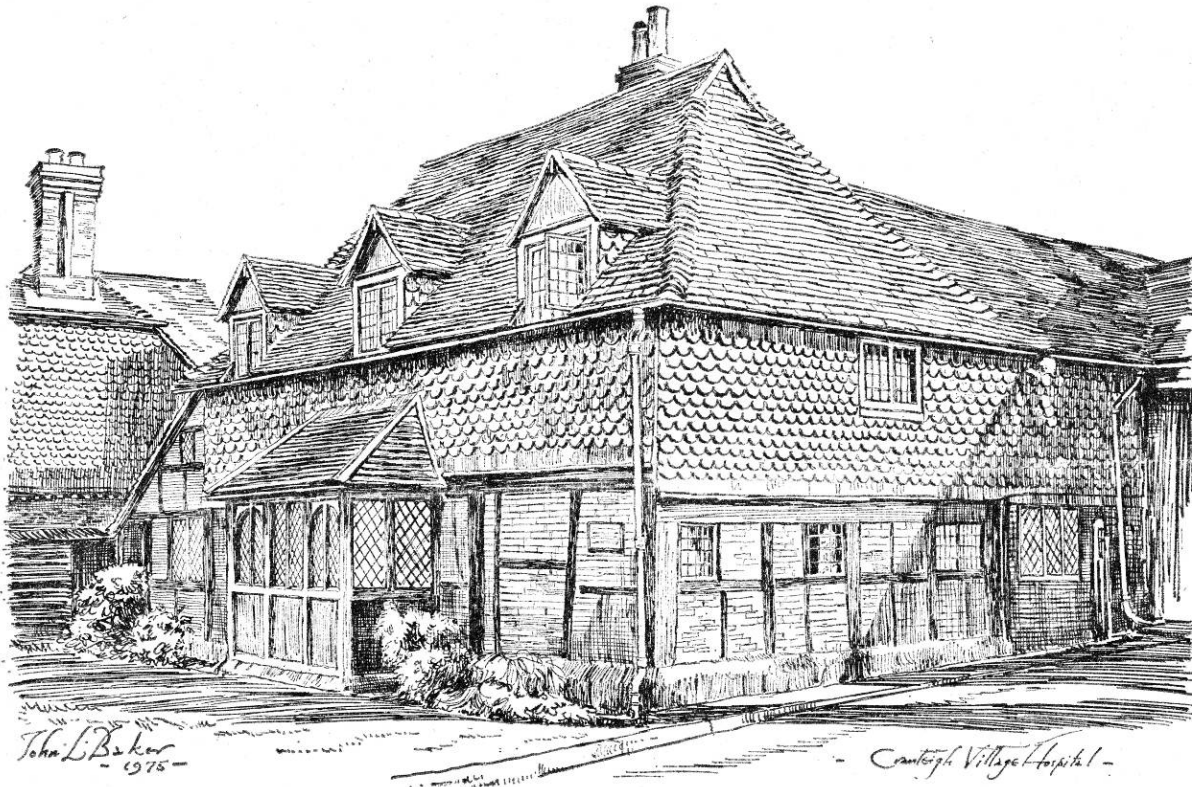
Fig 51 **Cranleigh Village Hospital, 1446**, giving away its age by the ancient hipped roof, with the little ‘gables’, useful for letting out smoke from the open hall. The dormers, chimney, porch and rear part are additions. Quite modern tile hanging helps to keep it weatherproof. There are fine crown posts inside. Drawing by John L Baker, reproduced courtesy of the *Surrey Advertiser*.

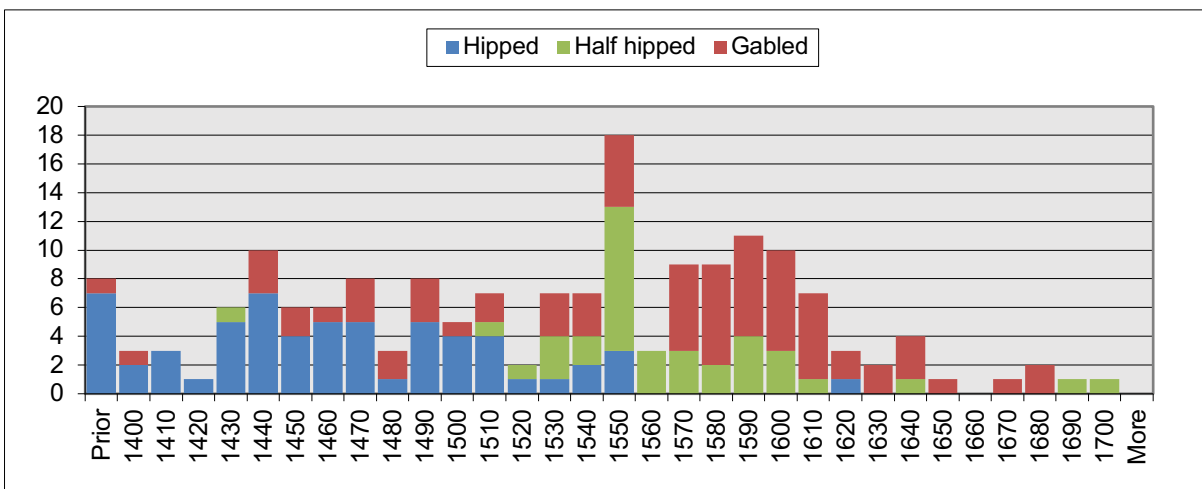
Fig 52 **Dates for different roof shapes.** The early gabled cases are all cross wings or in higher-status or town houses. The change from hipped to half-hipped is because of the switch from crown post to clasped purlin. The change to gabled roofs from about 1570 was in part because of the increasing use of brick which, in an end wall, gave simple and strong support to purlins.

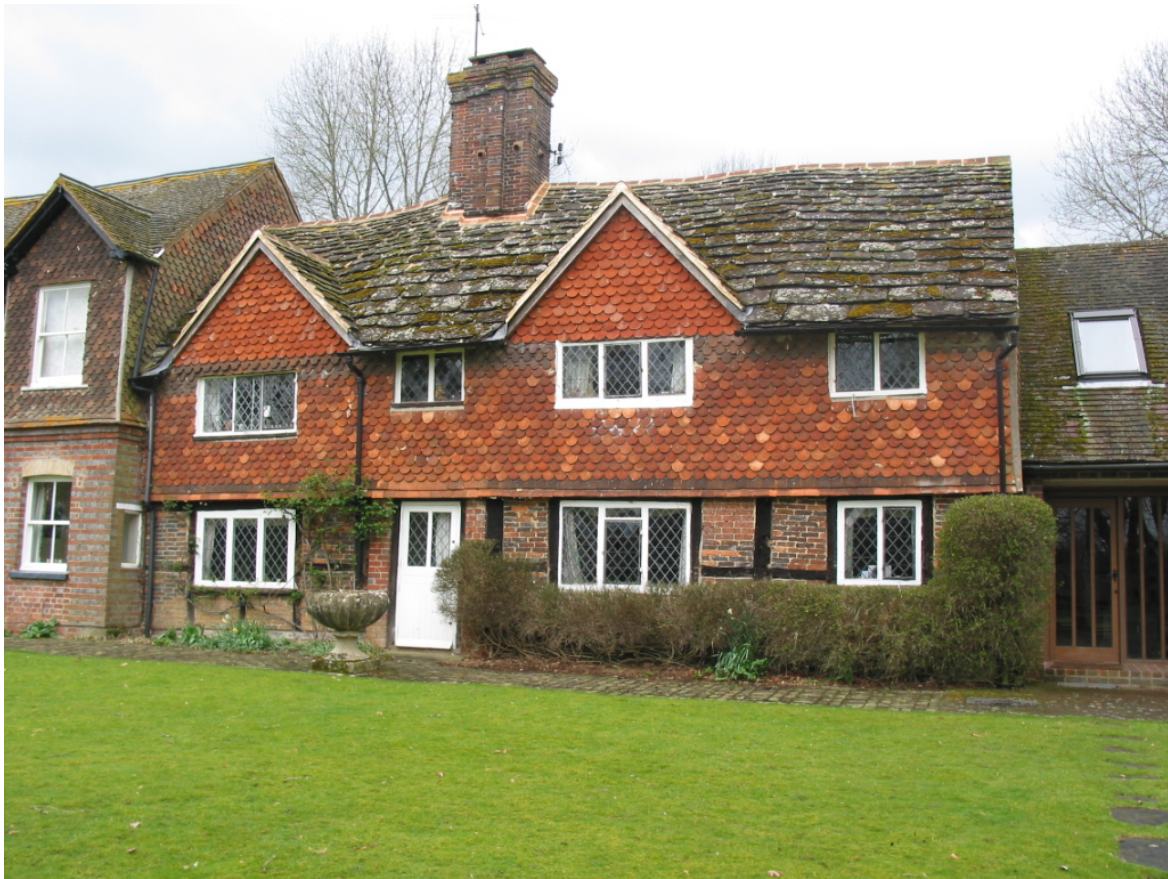
Fig 53 **Coldharbour Farm, Cranleigh, 1683**, showing its forward-facing gables, big central chimney, and Horsham stone roof.

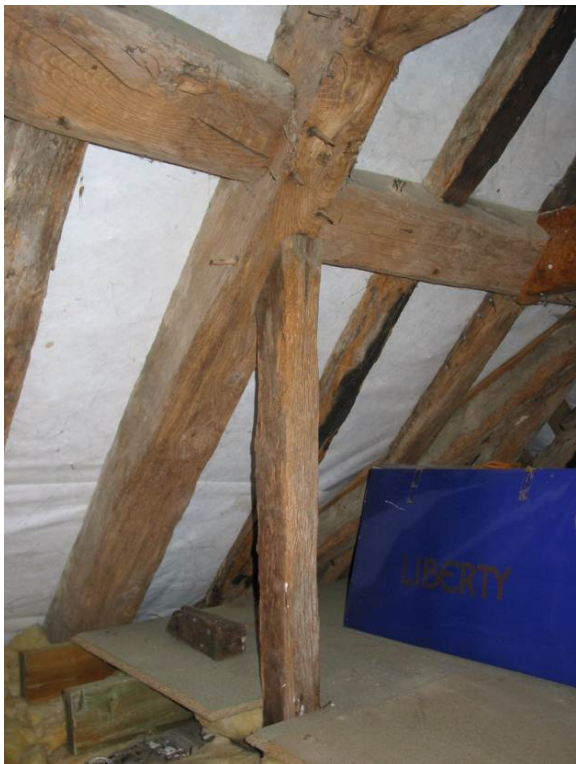
Fig 54 **Coldharbour Farm, Cranleigh, 1683**, staggered-butt-purlin roof structure. If the mortices were in line, they would weaken the structure. It is a good sign of a late 17th century house, although there are occasional earlier examples.

Staggered butt purlins are a neat variant on butt purlins in-line. The mortices on each side of the principal rafter are offset (fig 54, Coldharbour Farm). This removes a source of weakness and allows the use of thinner timbers. It is surprising that carpenters took a long time to adopt the practice. The first in an admittedly small sample was at Smallfield Place, Burstow parish, 1617, the fine stone house already mentioned. It had been thought that the method became commonplace in the last quarter of the 17th century (J Baker, pers comm), although there are some earlier examples. Certainly it replaced the queen-strut roof in the samplings after 1670; Hampshire examples are similar (Roberts 2010, 37). The style continued in common use in brick buildings in the 18th century.

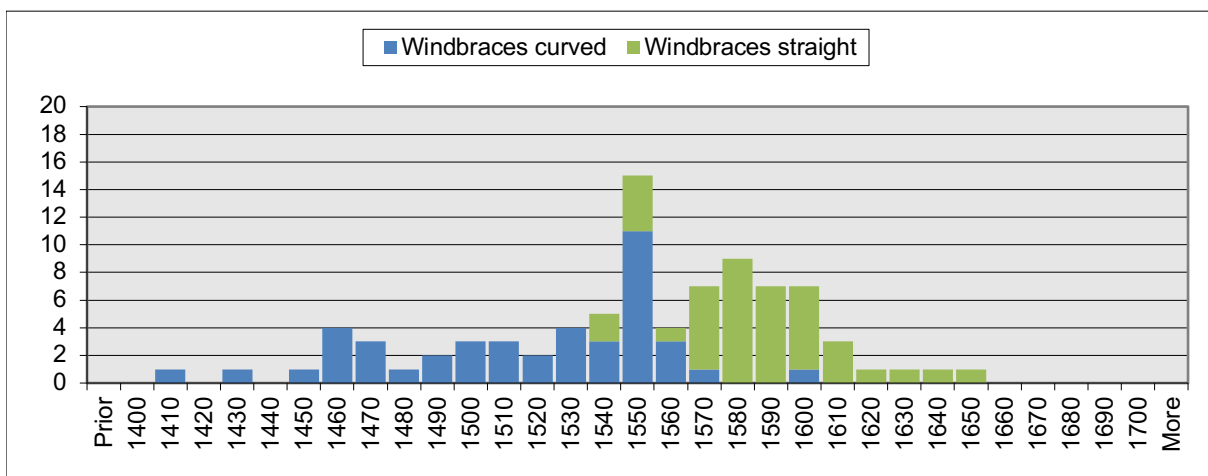
Fig 55 **Dates for the two main types of windbraces.** The change to the simpler straight sort is surprisingly sudden, about 1570.

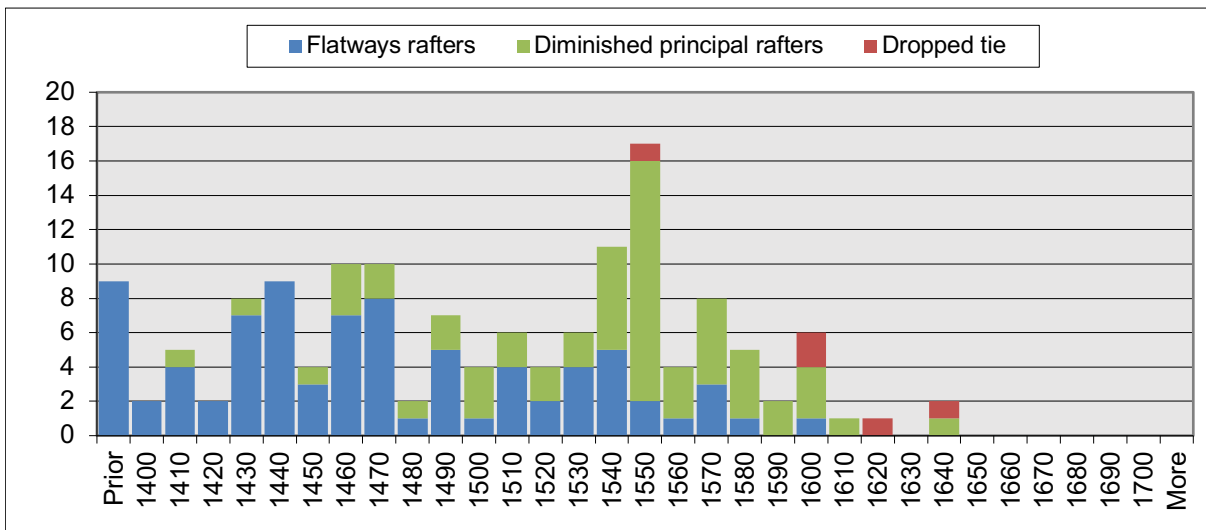
Fig 56 **Dates for various rafter structures.** Common rafters continued to be ‘flatways’ well into the 16th century, albeit in a minority against ‘on-edge’ (which are not shown). The technique of diminishing principal rafters was used in nearly all clasped-purlin roofs until about 1580 when simpler notched principals came into use. Dropped ties give more space to an attic, so are found in later houses.

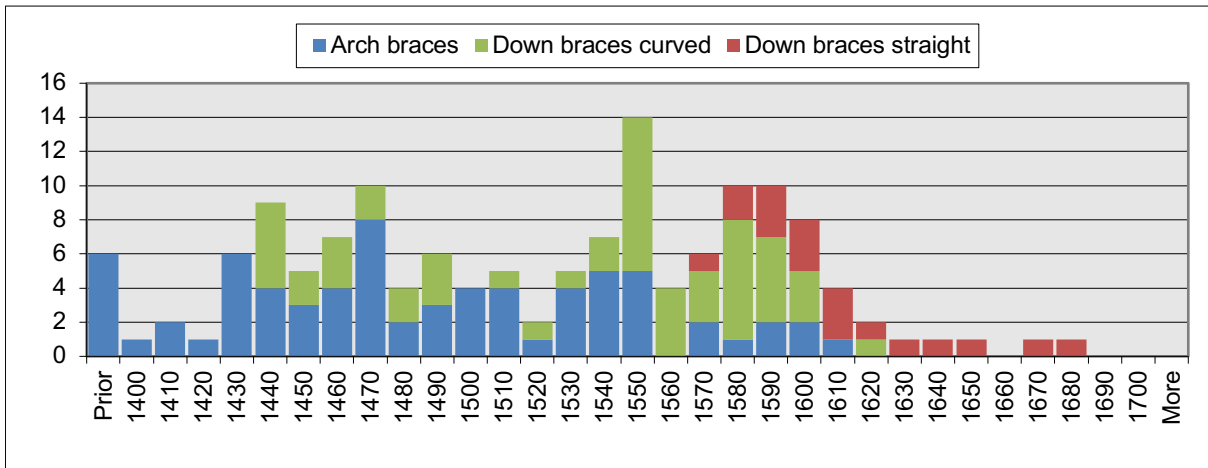
Fig 57 **Dates for different types of wall brace.** Very early braces are arched. Down braces do not come into use until 1440 and even then do not become prevalent until the mid-1500s. In the 1570s, they start to be simpler, straight braces, this type becoming the norm after 1600.

the old style arch braces also continued. The two bracing methods then stayed in parity of use until the middle of the next century (fig 57). Because down braces are not found before about 1440, they are another tangible feature that gives a clue as to when during the century a house was built.

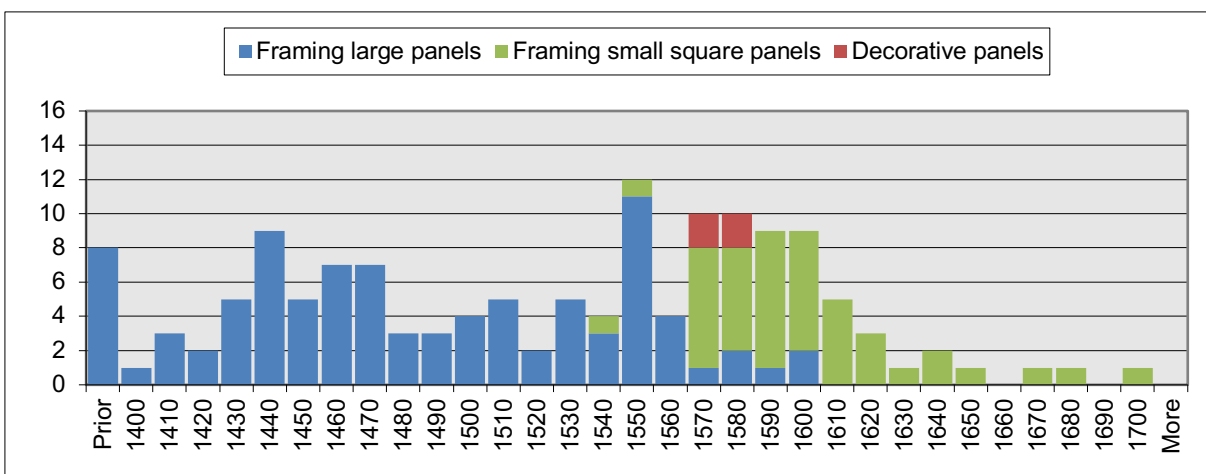
Fig 58 **Dates for different types of wall panel.** There is a sharp change about 1570 when the fashion for small (1 x 1 m) panels began. The intensely decorative ‘square-and-circle’ fashion seems to have been very brief.

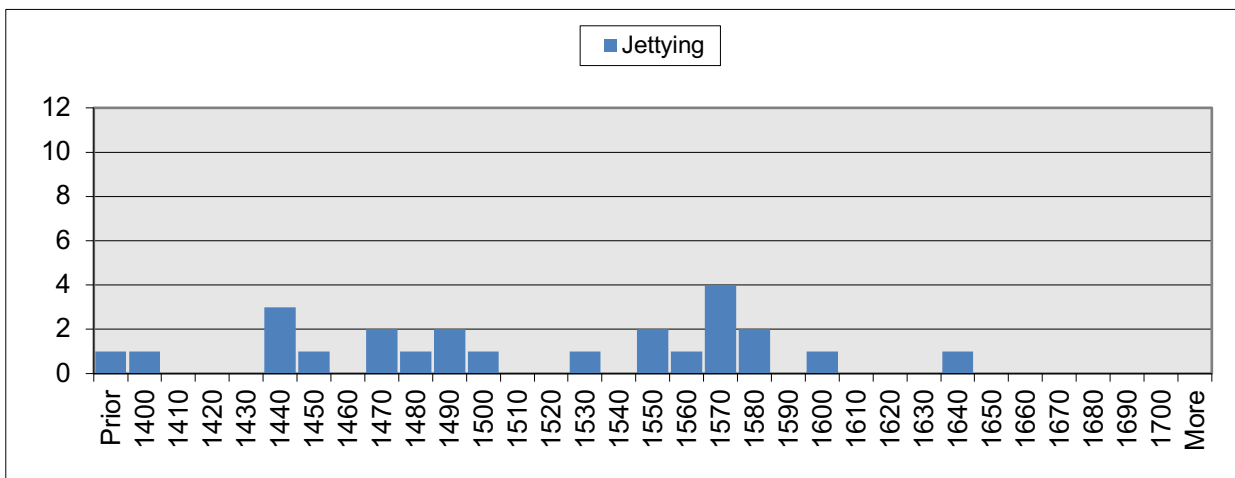
Fig 59 **Dates for external jetties**, including jettied cross wings (the great majority) and continuous front jetties. There is little dating significance.

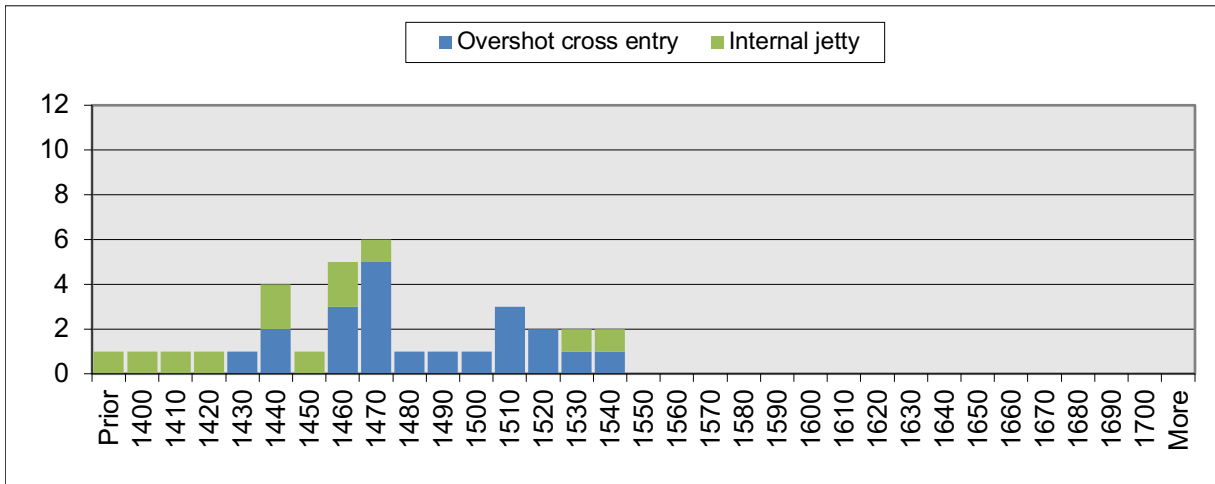
Fig 60 **Dates for overshoot cross entries and internal jetties.** They do not go together as often as expected. Overshoot cross entries are curiously peaked about 1470 and continue in use until the end of the open-hall period. Internal jetties are usually pre-1470 but can be later.

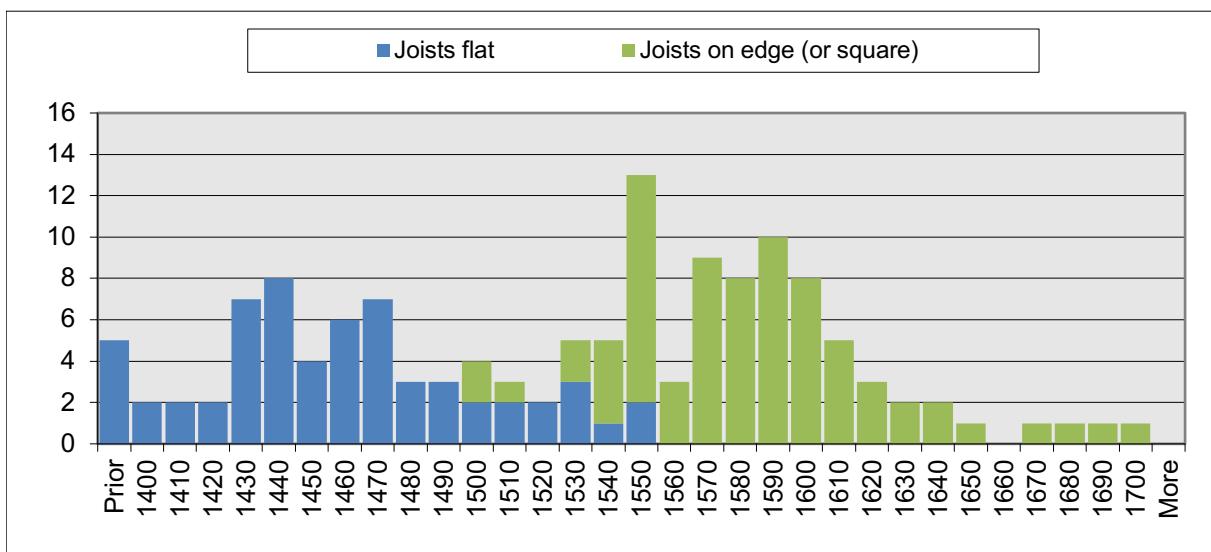
Fig 62 **Dates for joist types.** This is another of the ‘1540 changes’. It coincides with the change from open to floored halls, but there is no structural reason why this should be so.

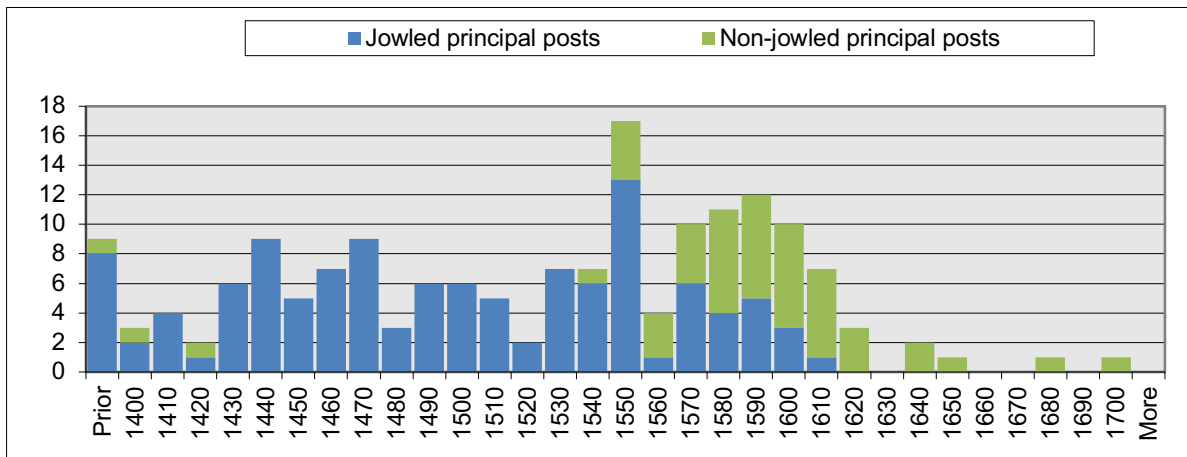
Fig 63 **Dates for the change from jowled to non-jowled principal posts.** This is earlier than expected, about 1560, but it took the next 50 years for the jowled post to fall out of use altogether.

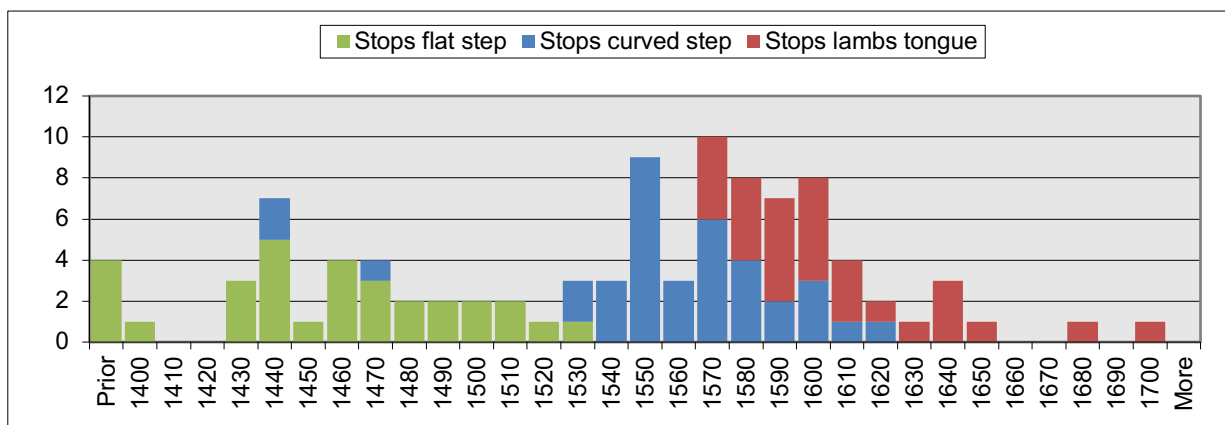
Fig 64 **Dates for different types of chamfer stops.** This is a helpful dating guide, with the changes at about 1540 and then after 1570.

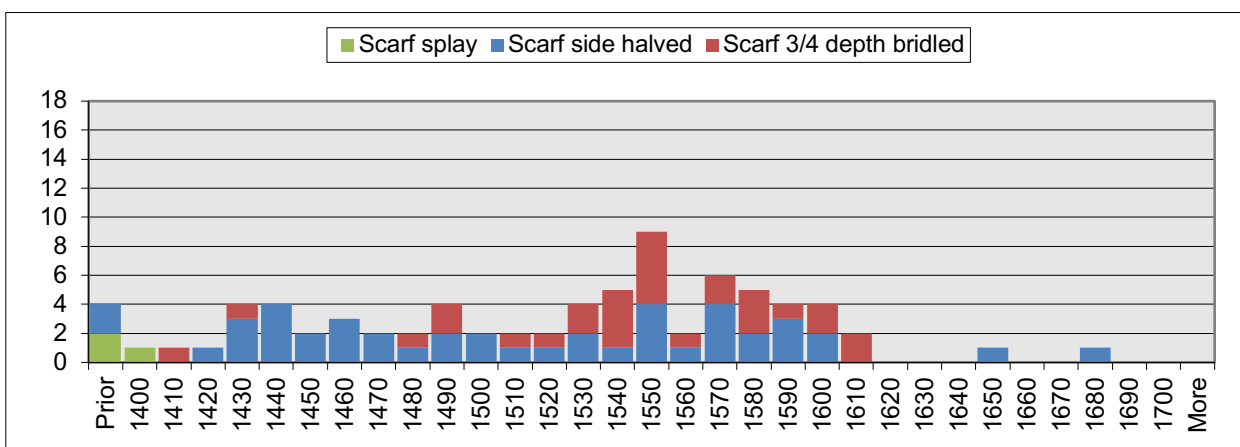
Fig 65 **Dates for different types of scarf joint.** Apart from a few early splayed scarfs, the side-halved and bridled scarf was the almost universal method of joining two timbers end-to-end. The only surprise is the frequent occurrence of the face-lapped and bridled three-quarter-depth scarf, apparently something of a Surrey speciality.

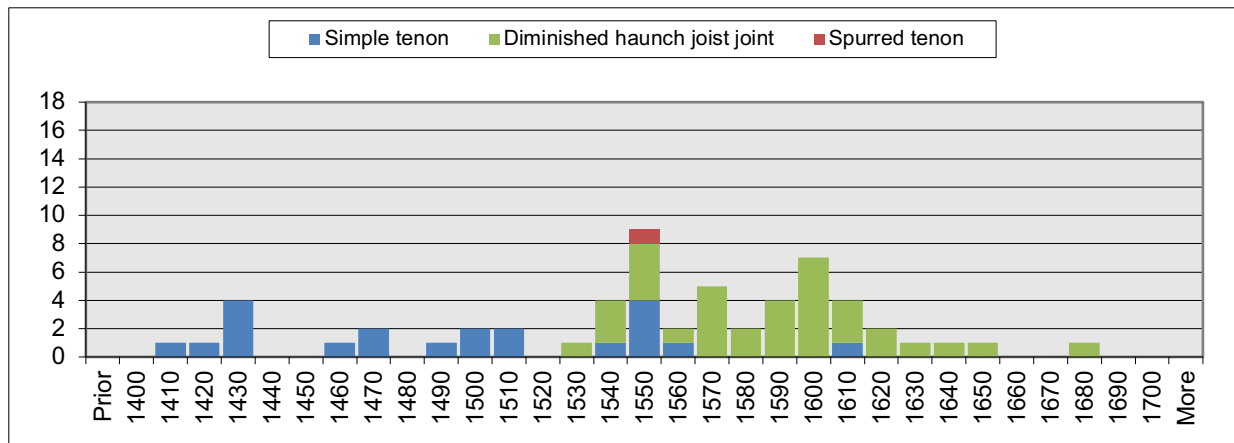
Fig 66 **Dates for the joint at the end of a joist.** The change from the simple tenon to the stronger diminished haunch method happened quite suddenly after its introduction about 1540. This is another of the changes that happened, seemingly together, around this time.
