THE DEVELOPMENT OF TIMBER FRAMING IN SURREY'S OLD BUILDINGS

An analysis and calibration by means of tree-ring dating

Rod Wild and Andy Moir

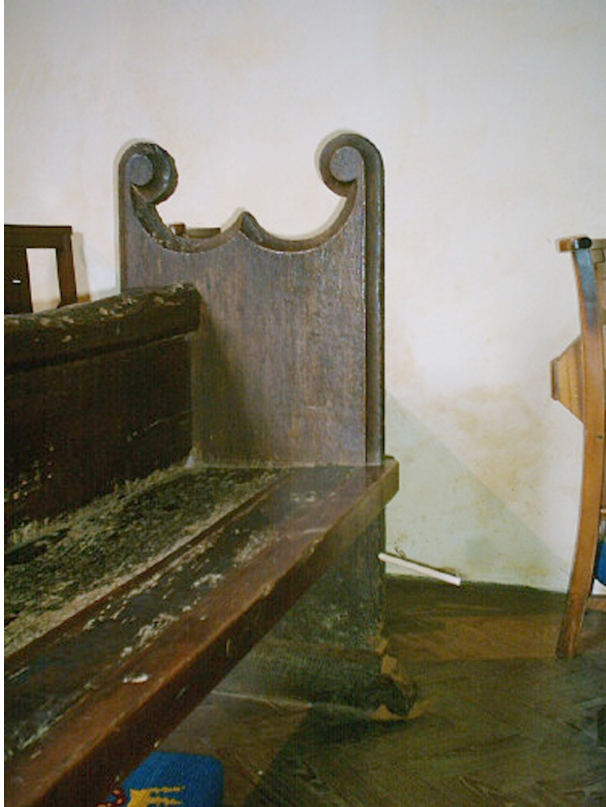
Fig 76 **Dunsfold church pews** dated to 1418 (modal). Simon Jenkins (2000, 673) suggested that they could be contemporary with the 13th century church, which could make them as old as any in England. This is now shown not to be so, but they are still ancient and of much interest. The bench-ends have deep cusps ending in knobs with holes for carrying lighted tapers. Six cores were taken from inconspicuous places. The dowel that can be seen at the bottom right shows one such place. It is good practice to mark each position photographically in this way as a record of from where they were taken.

The main aim of the dendrochronology at Dunsfold was to attempt to date the ancient benches, or pews (fig 76), suggested by Simon Jenkins to be as old as any in England (Jenkins 2000, 673). The dendrochronology was difficult, with a need to take samples from inconspicuous parts of quite slender timbers, but it was successful, producing a date of 1418 (modal). This is not quite as early as expected, but is still remarkable.

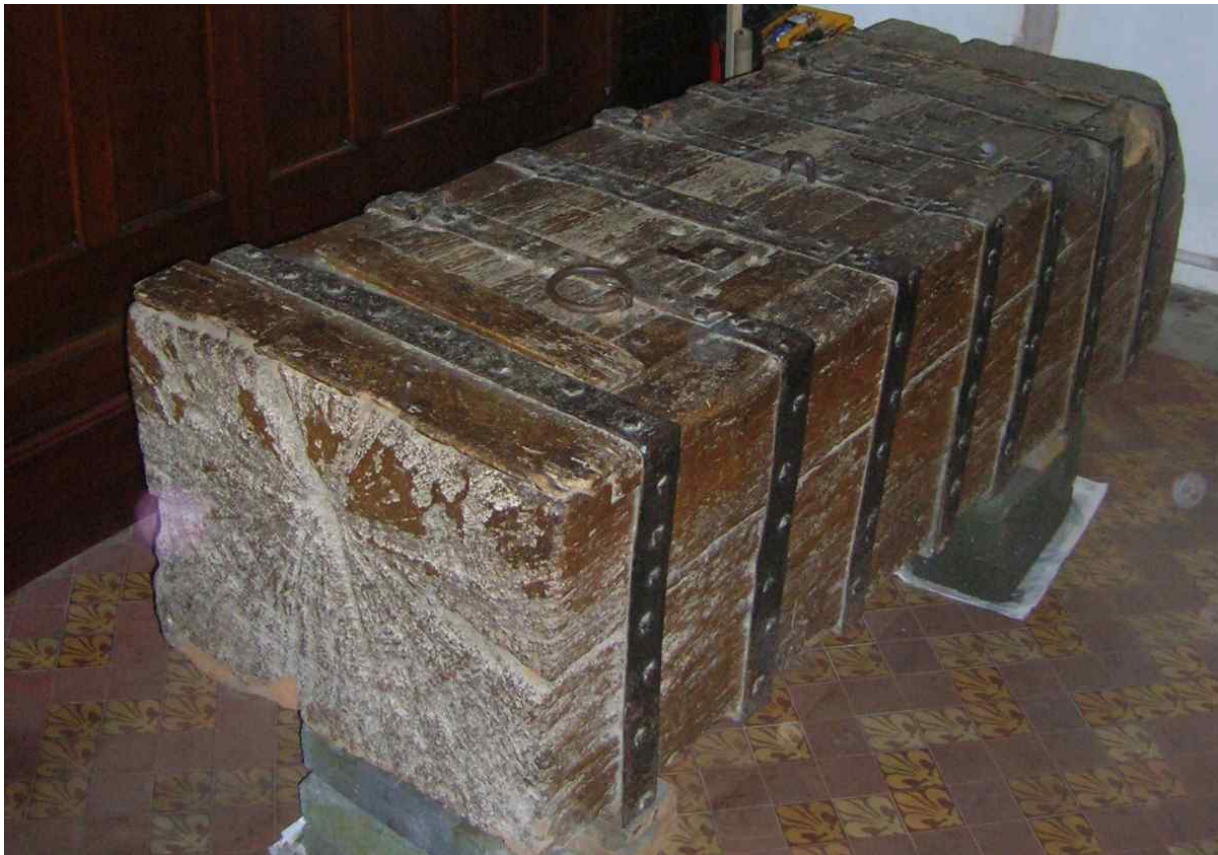
Fig 77 **Betchworth church chest** was hewn from a single great oak trunk, measuring 2.17m long, 0.80m wide x 0.65m high. The sides are approximately 15cm thick, the ends 25cm. There is a lid, equally heavily built, in two pieces. The chest has heavy iron hinges and is encased by seven great iron straps. It is secured by three locks, the keys of which are traditionally held by the vicar and churchwardens, so it could be opened only by three of them in concert. It was dated to 1505–37 (modal 1521).

The work at Betchworth church was not about the fabric, but to try to date the old church chest (fig 77). Pevsner (1990, 109) describes it as, ‘Massive and undatable dug-out, with seven iron staples’. In another remarkable feat of dendrochronology, the whole was jacked up and samples drilled from underneath. Previously, there was no idea as to its date, but the dendrochronologist was able to date it to 1505–37 (modal 1521).

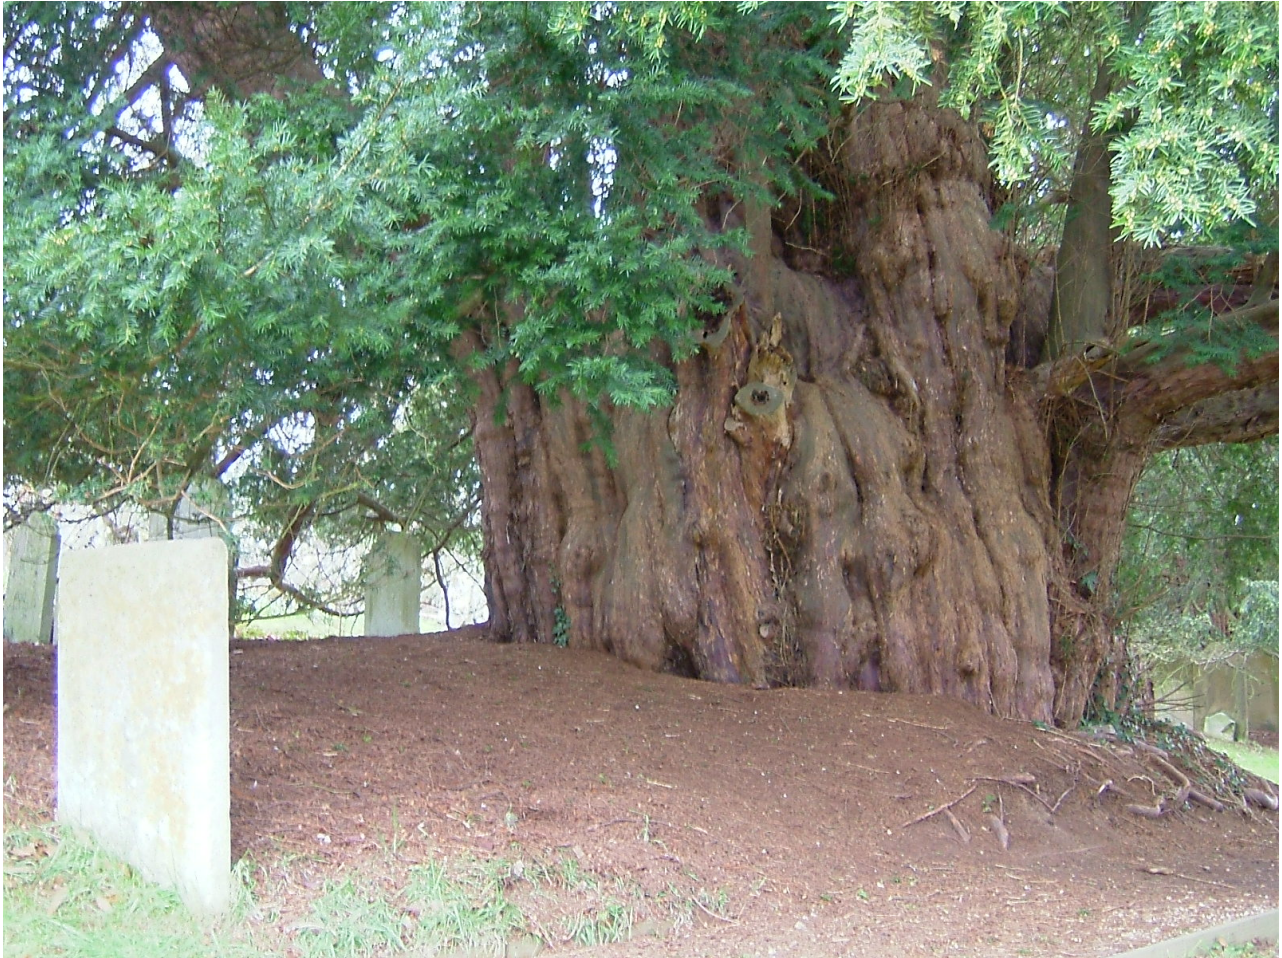
Fig 78 **The Hambledon Yew** was dated to c 800, making it the oldest yew dated by the Project. A very thin core was taken, not enough to damage the tree in any way. Normally this would be enough, allowing a simple count of the total number of rings, immediately giving the exact age, but when the tree is hollow, more sophisticated methods are required involving adjacent younger trees. The dating is a strong indication of a pre-Conquest planting, and the existence of an earlier church. Photograph by Andy Moir.

Incidental to the main Project, Tree-Ring Services dated four ancient yews in Surrey churchyards: Capel (c 1600), Peper Harow (c 1300), Dunsfold (c 1200) and Hambledon (c 800; fig 78). These are approximate dates as the method is different. Ancient yews are hollow. A very thin core is taken from the outer tree rings and these can usually be dated precisely, but the number of lost earlier years of growth is not known. The technique is to find a younger neighbouring yew tree, and there are usually some in the churchyard. This is cored to measure how fast yew trees have grown in their earlier years – when they grow faster – in the local conditions. This rate of growth is mathematically transformed into the inside of the neighbouring hollow yew to give a total age estimate. Although approximate, the method gives a fair estimate and is
