# DBRG NEWS

**June 2026**

### Land drains, thatch ties and Lidar

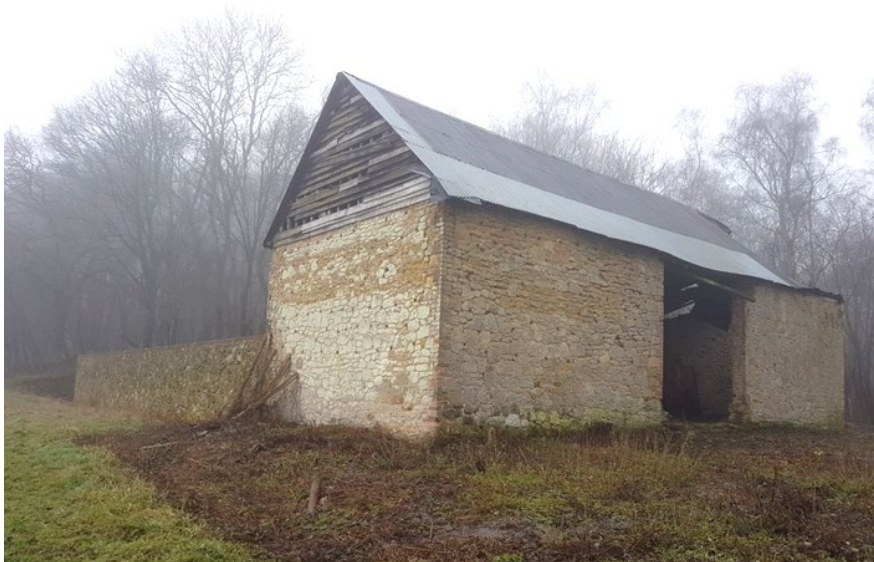
The stone barn from the North East. It stands on the edge of woodland.

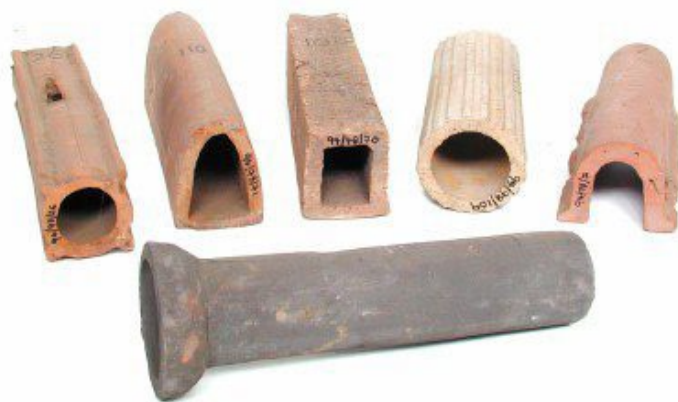
Examples from a collection of drainage tiles and tools accumulated by Adas Soil and Water Research Centre, Anstey Hall, Trumpington, Cambridge (MERL 94/78/1-111)

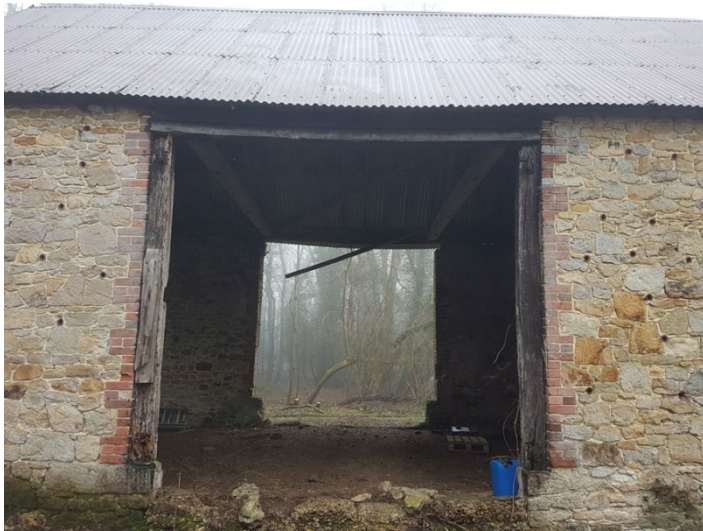
South elevation of the barn showing the round land drains to allow ventilation

So, where do land drains fit into the story? Well, all walls of the barn have built into them a series of land drains to provide ventilation to interior of the barn. These are integral to the stone wall which is narrow at just a brick and a half thick at the doors.

The drains used in this barn appeared to be extruded (a later manufacturing process) suggesting manufacture of drains was well established by the time the barn was built. Being made of fired clay land drains were taxed under the Brick Tax. However from 1826 to 1850, when the tax was abolished, they were exempt if the word "DRAIN" was stamped on them. We hope to recover some of the pipes when the building is converted to further narrow down the construction date.

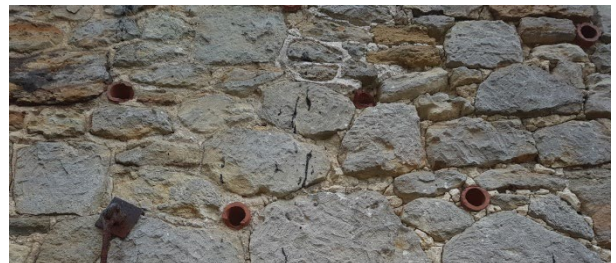
Detail of land drains used as ventilation

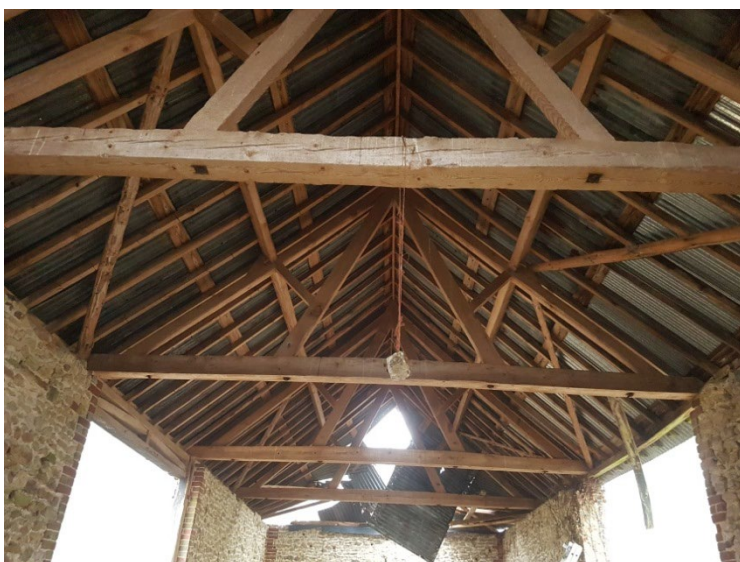
Barn interior looking West.

Now the barn was known to be 19<sup>th</sup> century at the earliest, the softwood roof was looked at more closely. This is scientifically designed with iron bolts holding it together.

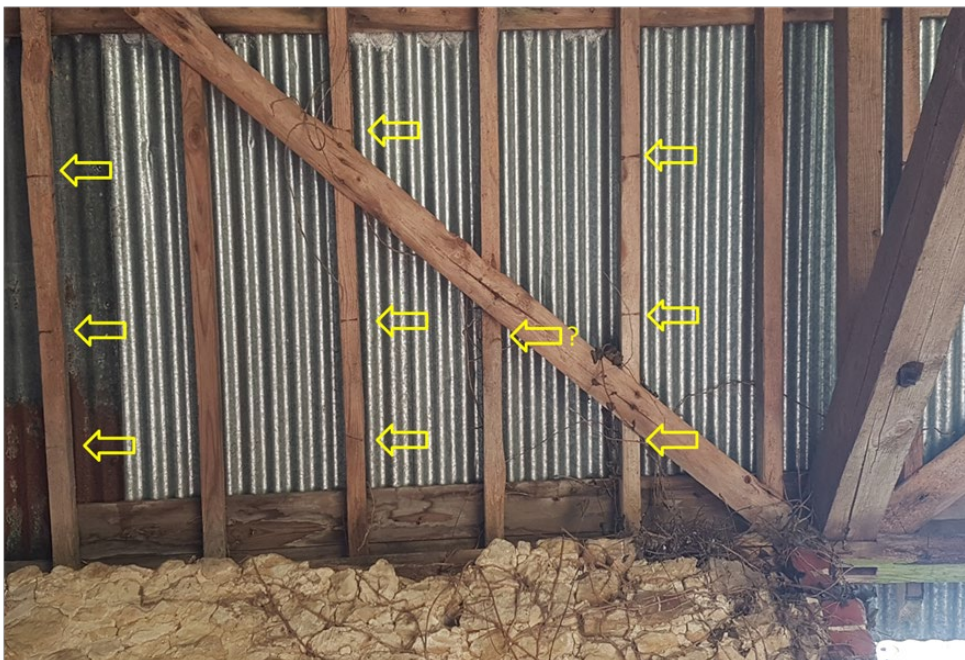
Black tar stains from thatch ties occur on the rafters.

The barn has a corrugated iron roof covering, but was this original? The answer came from the stains on the rafters of tarred thatch ties, as marked with arrows on the photo below. This method of fixing the first course of thatch was used throughout Surrey in the 19<sup>th</sup> and early 20<sup>th</sup> centuries, and the marks will commonly be found in barns. “Thatch” is used here to describe a harvested roof covering. Being next to ancient woodland coppiced “chip thatch” may have been used here.

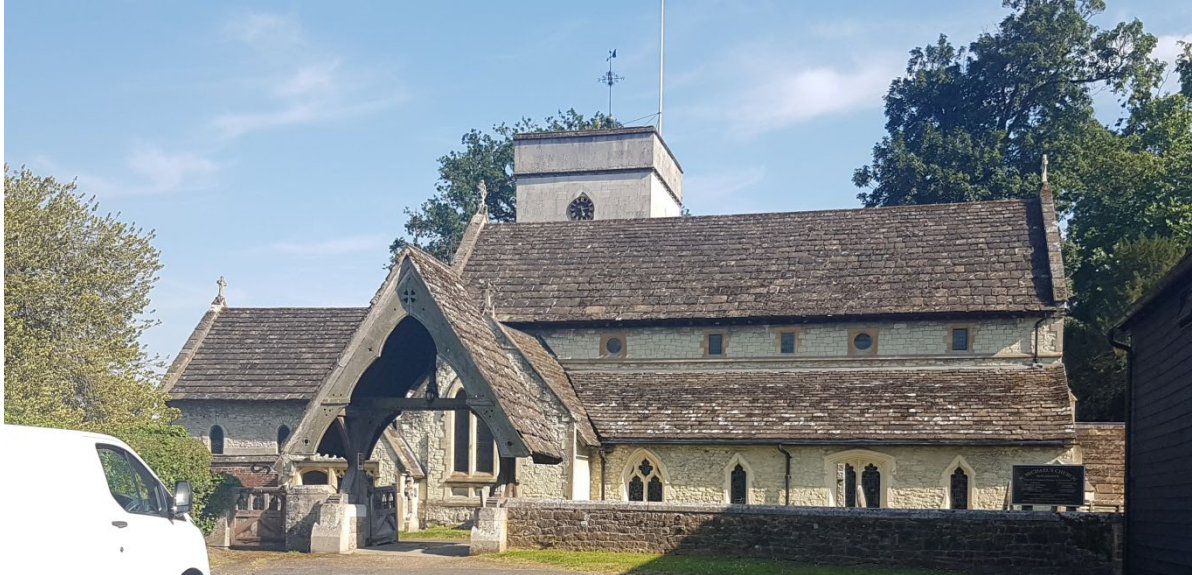
Picture of Betchworth Church

We started by looking at the Reigate Stone masonry of Saint Michael's church. The early work is random with no clear horizontal courses or 'lifts' where the lime mortared stonework had been allowed to set before the next lift was raised. We speculated that periodic repair and replacement might have destroyed any level courses, if indeed they did exist. In contrast the very tops of nave walls used squared stones of various sizes. These relate to the 1883 reroofing. A third style with polygonal facing stones appearing like crazy paving was seen on the south wall of the South Chancel. This wall had been refaced when two windows were added to match the original central one in the mid 19<sup>th</sup> century.

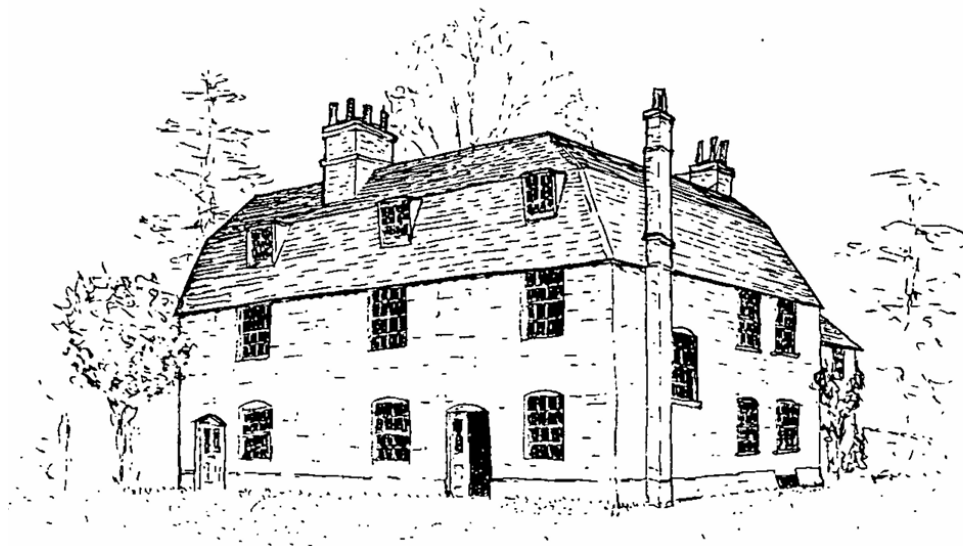
The Dolphin PH to right of large stack, cottage to left; now all in pub use (from an old photo).

Leaving the churchyard by the east gate we saw The Dolphin P.H. which was built on a long triangular plot at the junction of The Street with Wonham Lane. The Custumal associated with the 1634 map records this plot was then occupied by a house held by Thomas Alchin. The current building, probably built as a pub, is of two storeys plus integral attics in a gambrel (Mansard) roof. It probably dates from the mid 18<sup>th</sup> century.

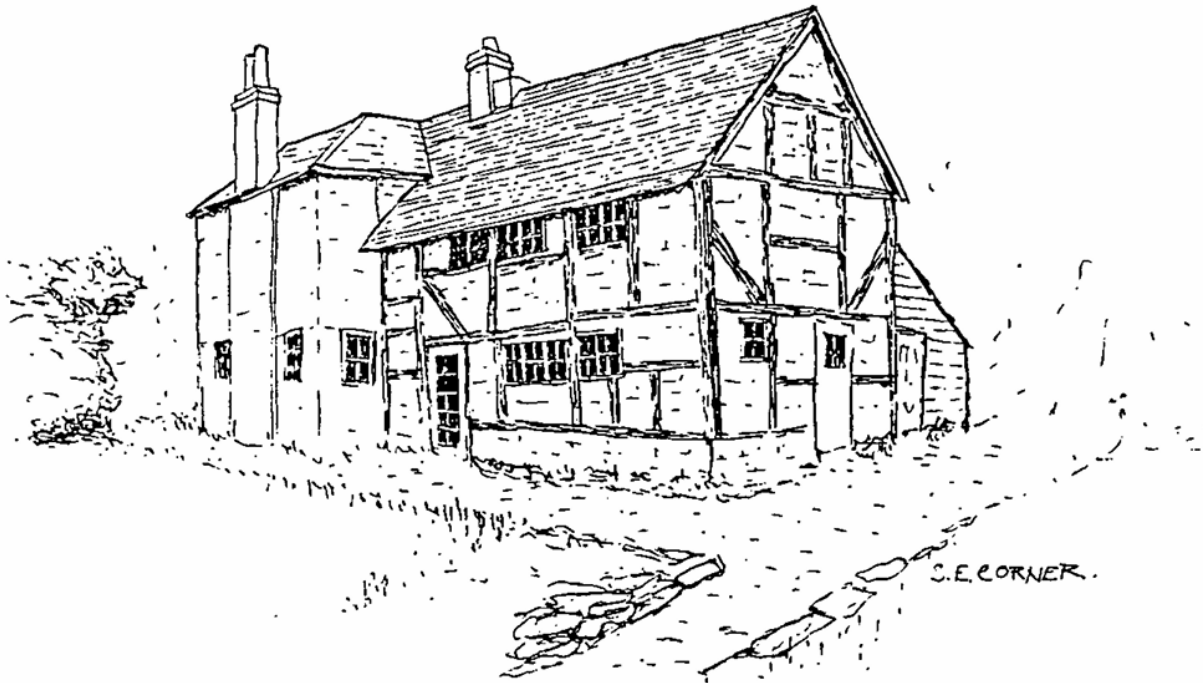
The Gardens, late end smoke bay.

Next, still on what had been church land is The Gardens which sits on a plot labelled p'son (parson?) on the 1634 map. The small square framing of this two and a half bay building is well preserved, as is its end smoke bay (late 16<sup>th</sup> century). The house has an addition to the rear, barely seen from Church Street, of which more later.

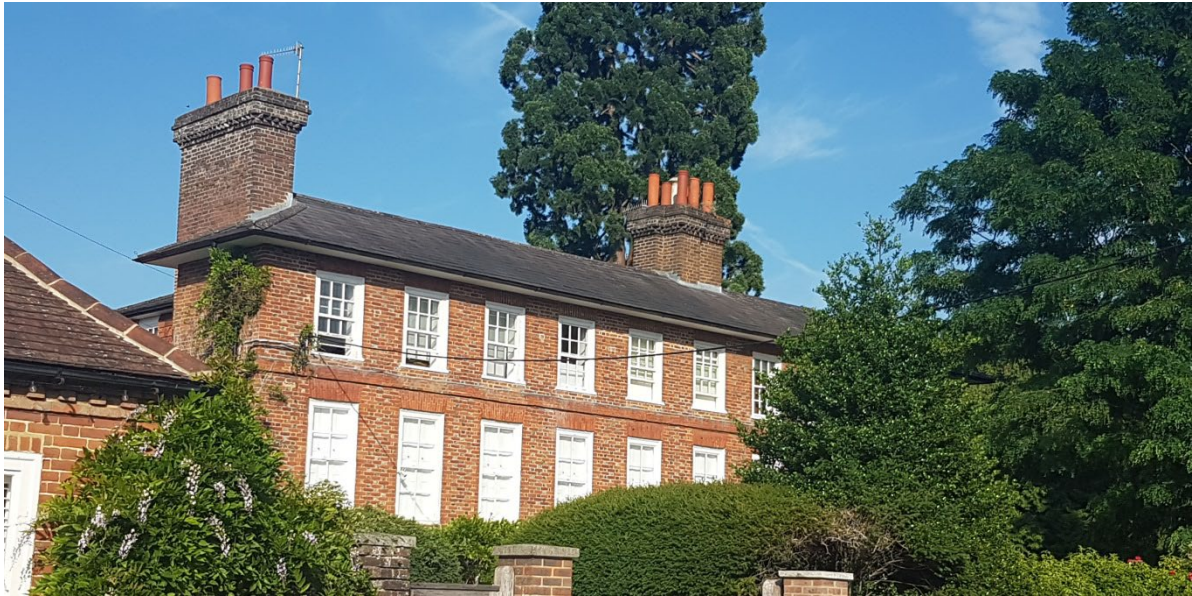
Betchworth: The Gardens 2993

We returned to the hall in Church Street by walking round the west side of the Walled Garden to view the back of The Garden. The extension takes the form of a double fronted Regency cottage. Martin explained that the path we were on was an old drive to Betchworth House. Repton had tried to dissuade the then owner from using it because the route "was not sufficiently interesting". Instead "The road through the village therefore must be improved by a little attention to the neatness, repair, and decoration of all the houses in it: if possible those which do

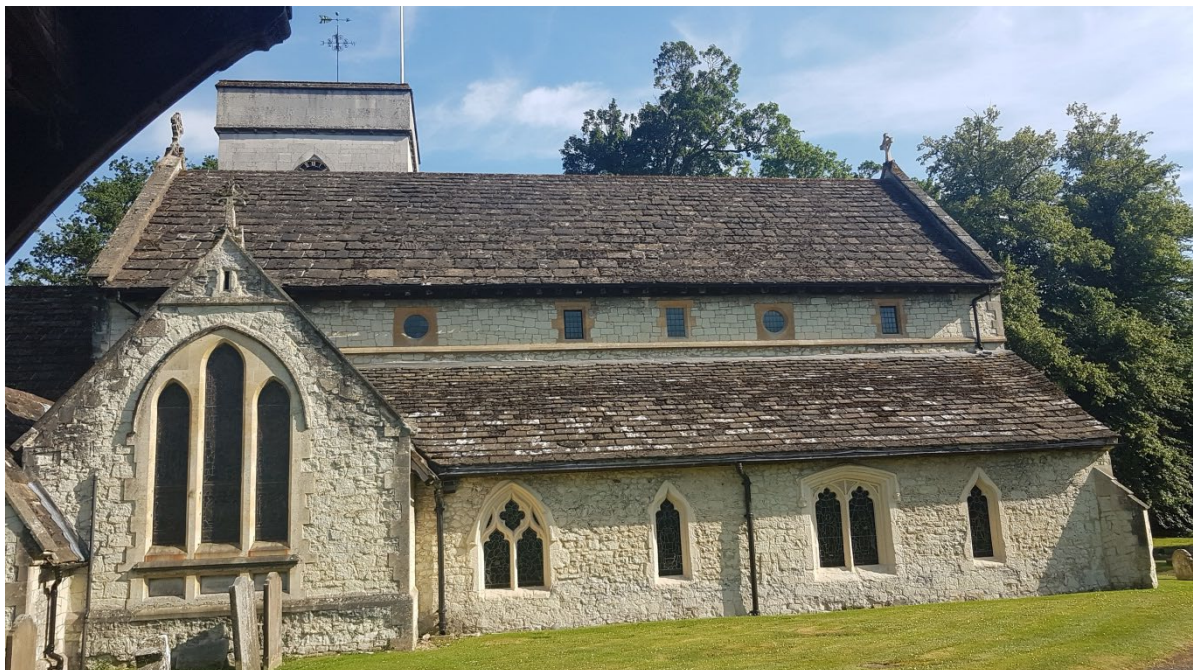
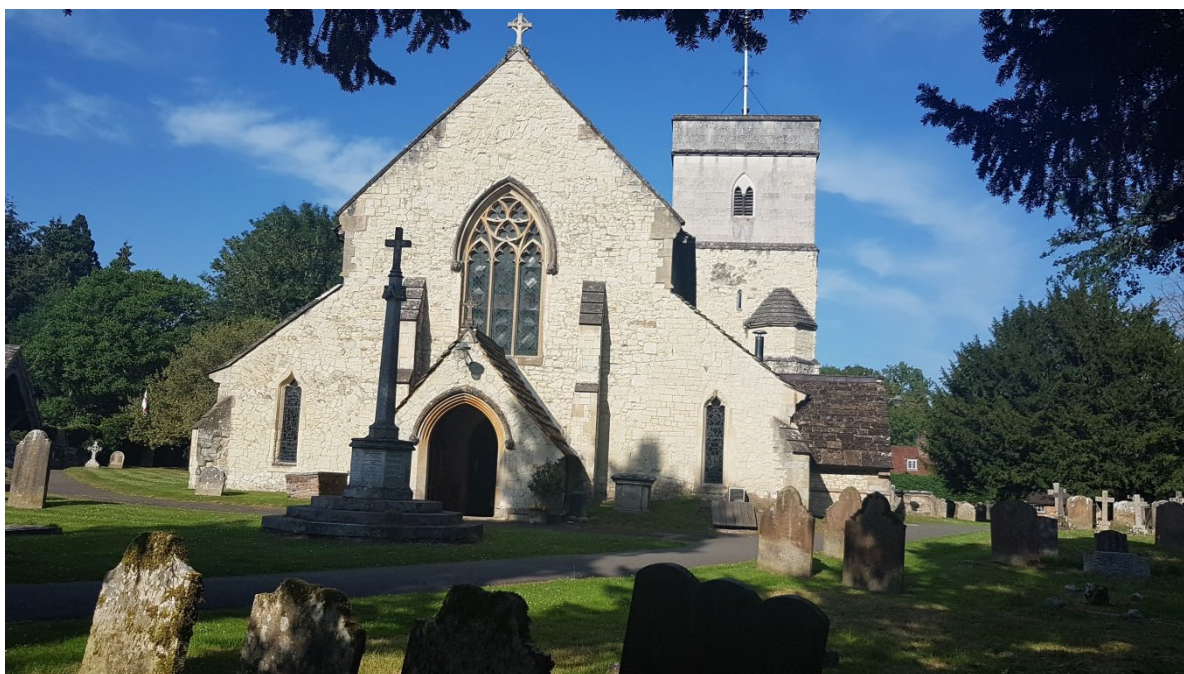
Nineteenth Century “crazy paving” stonework
